# AIRCRAFT ACCIDENT REPORT

AIRPEACE/2018/12/14/F

**Final Report on the Serious Incident involving Boeing  
737-300 aircraft belonging to Air Peace Limited with  
nationality and registration marks 5N-BUO which  
occurred at FL 310 enroute Enugu from Lagos  
on 14th December, 2018**

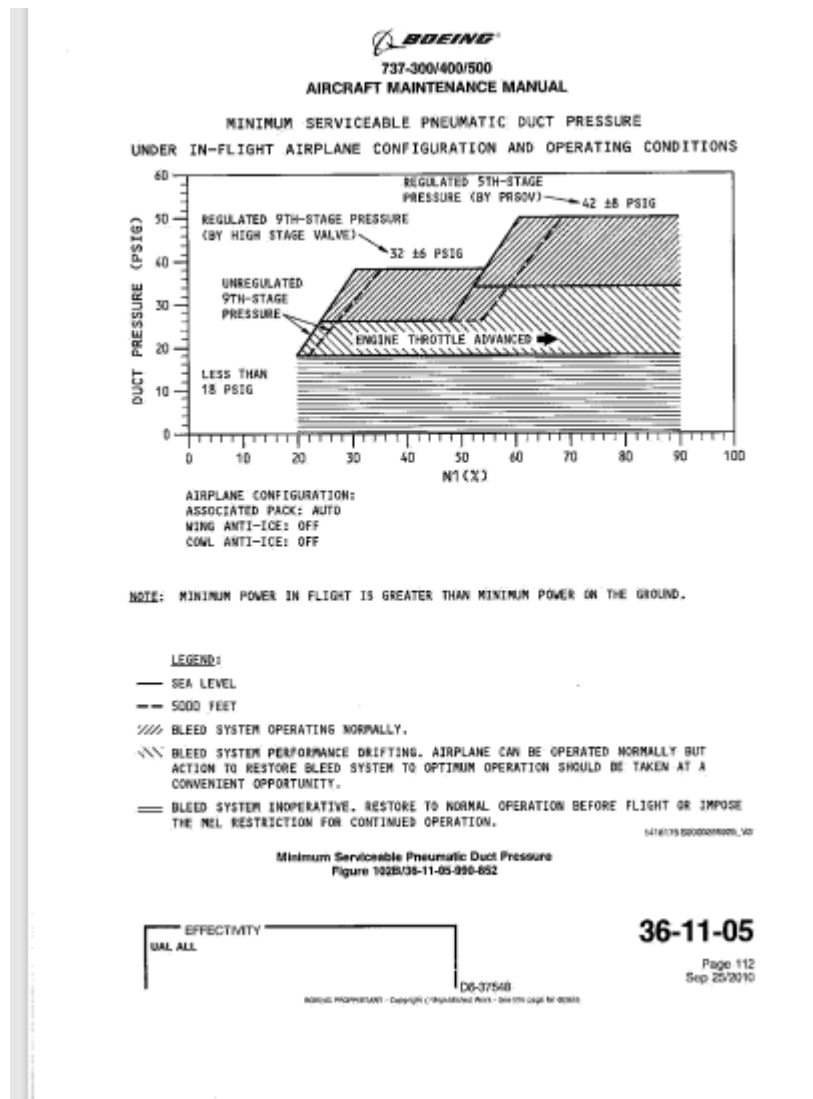
Engine No. 1 bleed switch on the air-conditioning panel was placarded 'INOP'. The left duct pressure was 18 psi and this was entered in the Deferred Defect Log book on 12th December, 2018 with a limit of 22nd December, 2018. Action on the low bleed on engine no. 1 was raised in accordance with MEL (36-05 CAT C).

On 12th December 2018, a defect was recorded in the tech log as follows: 'LARGE DIFFERENCE IN L & R DUCT, INDICATOR IN CLB & CRZ, L- 18 PSI, R-48 PSI'. The action taken was 'ADD 076 RAISED IAW MEL 36-05 CAT C'.
