AIRCRAFT ACCIDENT REPORT

AIB/NCAT 2006/10/10/F

**Report on the Accident involving
TAMPICO Club 9 Aircraft, Reg. 5N-CBF
at Zaria, Kaduna State, Nigeria
On 10 October 2006**

Aircraft Accident Report No: (NCAT/2006 /10 /10/F)

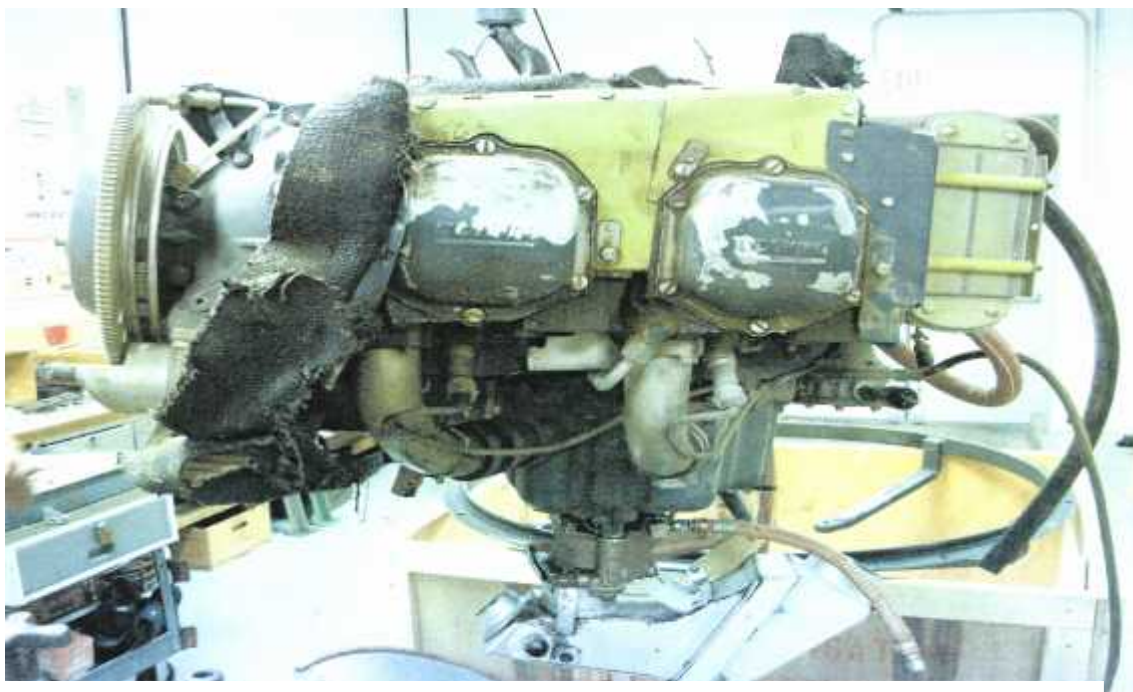
Fig.1-8 Photograph showing 5N-CBF Engine 0320-D2A in the facility of Lycoming USA for Tear Down/Stripping

The cross-threading of 90^o fitting at the carburetor end of the fuel hose that runs from the engine fuel pump to the carburetor fuel inlet filter, resulted to fuel leakage, loss of fuel pressure to the engine and consequent engine fuel starvation.

The aircraft engine was taken to Lycoming engine factory in Williamsport, USA where the stripping exercise revealed the cause of the engine power loss. (See Figures 1-8, 1-9, 1-10, 1-11, 1-12, and 1-13).
