AIRCRAFT ACCIDENT REPORT

EMIRATES-HAK/2015/07/06/F

Report on the Serious Incident involving an Emirates Boeing 777-200 aircraft with registration mark A6-EWD and a parked Boeing 737-400 aircraft belonging to HAK Air with registration mark 5N-BOU which occurred at Murtala Muhammed Airport, Ikeja, Lagos on 6th July, 2015

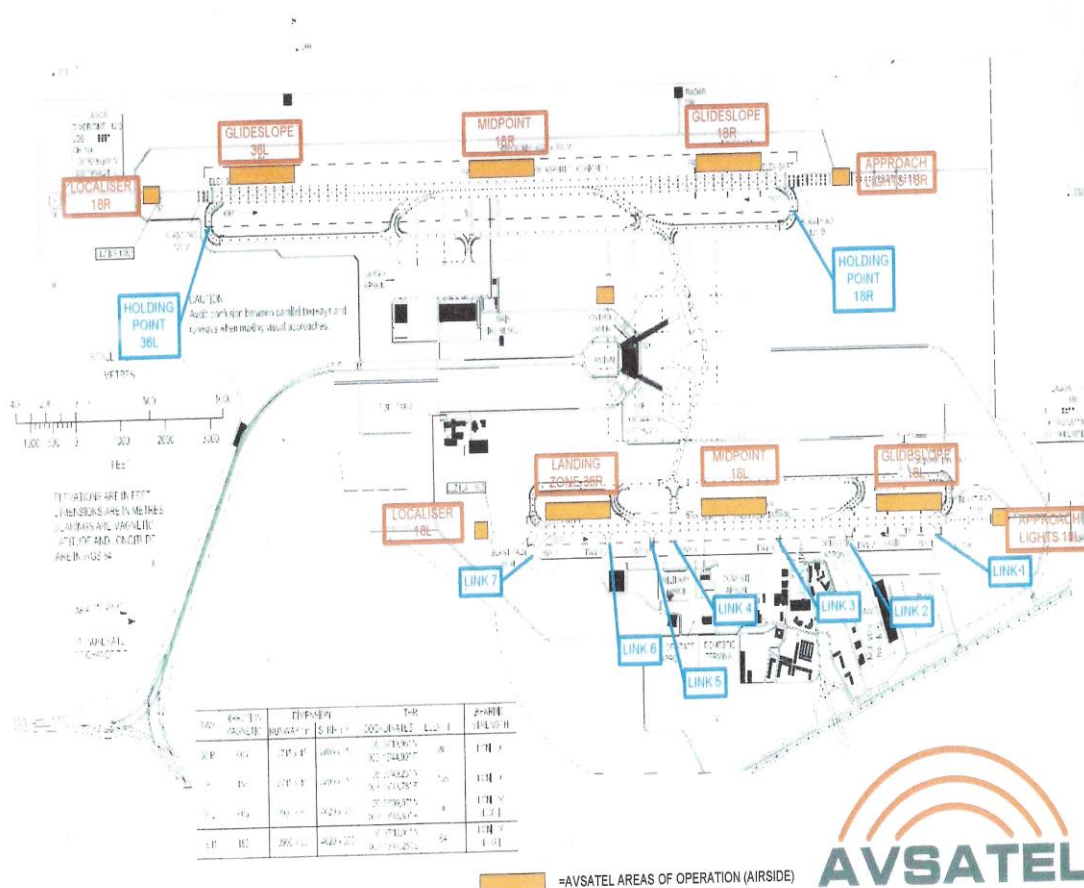
Figure 1: Layout of the aerodrome

The incident happened in the General Aviation area of the airport. Most of the flood lights provided at the Apron of the General Aviation Terminal were unserviceable at the time of the occurrence.
