AIRCRAFT ACCIDENT REPORT

NPF/2019/08/03/F

Accident Investigation Bureau

Report on the serious incident involving a Bell 429 helicopter with nationality and registration marks 5N-MDA, operated by the Nigeria Police Airwing, which occurred at Nnamdi Azikiwe International Airport, Abuja On 3rd August, 2019

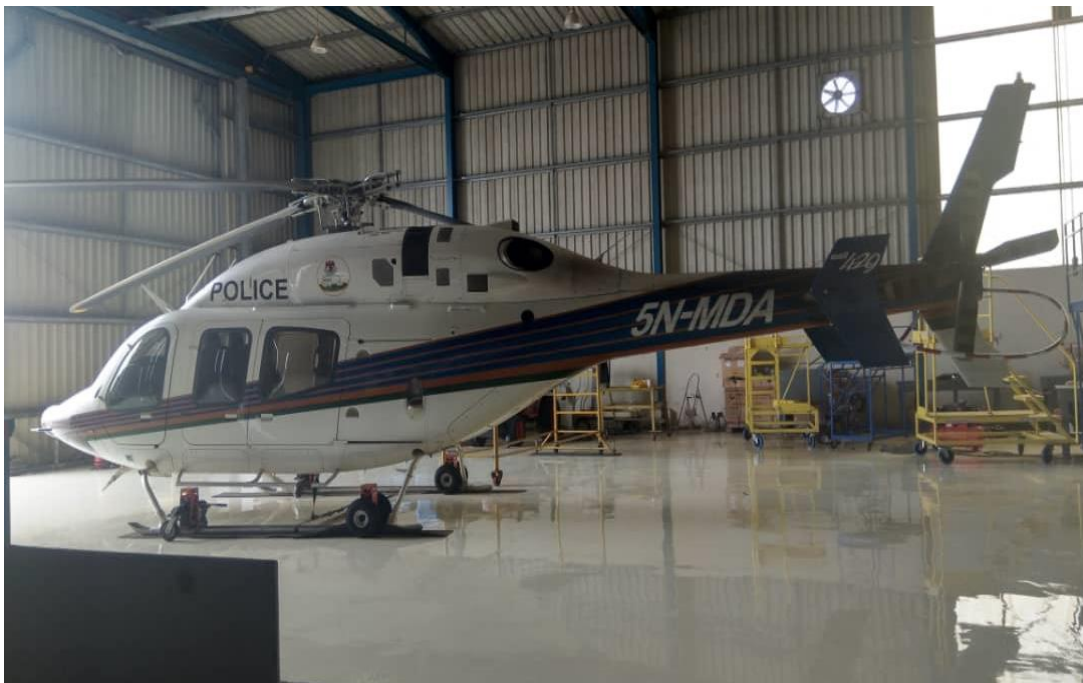
Figure 2: Picture of the 5N-MDA

The helicopter had been moved from the site of the occurrence into the hangar and the damaged main rotor blade disassembled before the arrival of investigators.
