AIRCRAFT ACCIDENT REPORT

MEA-TURKISH/2020/07/29/F

Accident Investigation Bureau

**Final Report on the serious incident involving Airbus 330-243 aircraft operated by Middle East Airlines with nationality and registration marks OD-MEA and a parked Boeing 777 aircraft operated by Turkish Airlines with nationality and registration marks TC-LJC which occurred at Murtala Muhammed International Airport, Lagos
On 29th July, 2020**

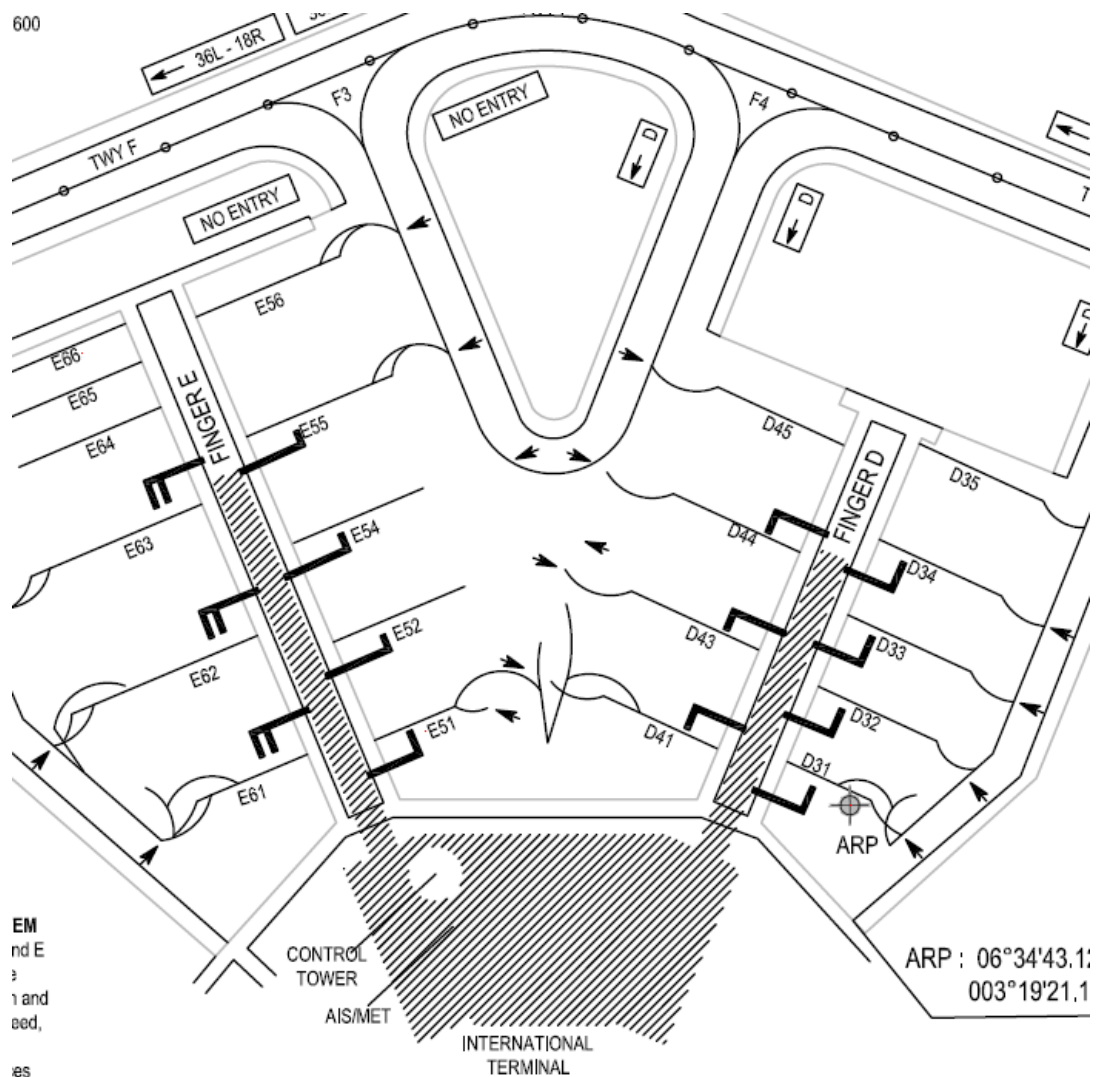
Figure 2: The layout of the parking bays at Murtala Muhammed Airport

1. Turkish airline TC-LJC was parked short of the B777 designated stop line marking point on the apron by about 13.5m.
2. Inadequate safety oversight on NAHCO apron operations by FAAN
