AIRCRAFT ACCIDENT REPORT

AASL/2021/02/16/F

Final Report on Serious Incident involving a Boeing 737-500 aircraft with nationality and registration marks 5N-SYS operated by Azman Air Services Limited which occurred on Runway 18R, Murtala Muhammed Airport Lagos; Nigeria on 16 February 2021.

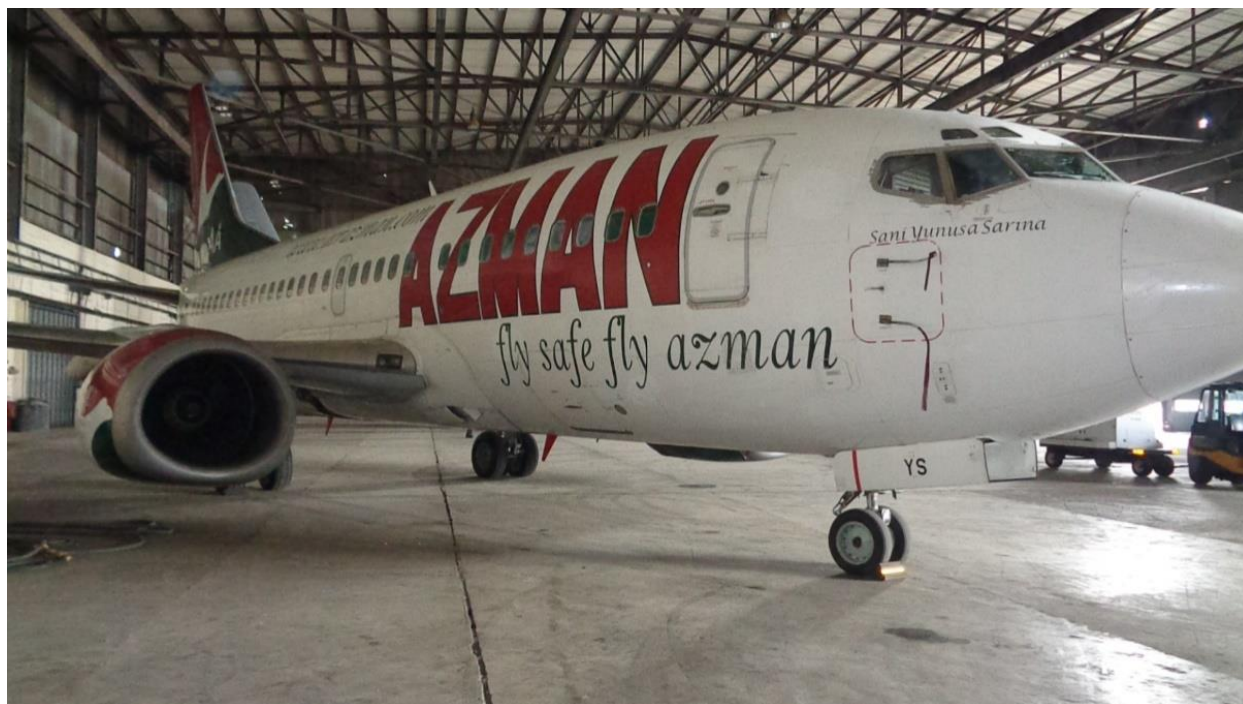
Figure 4: The Aircraft parked at the military hangar at DNMM after tyre replacement

The aircraft touched down after Link Alpha 2 of runway 18R and all the main wheel tyres burst. Flying debris from the burst tyres got into the No. 1 engine and the aircraft stopped on the runway after Alpha 3. The tyres were heavily worn-out exposing the canvass. Large reverted rubber tyre debris was found stuck in the left trailing edge flap. Several inlet fan blades on No. 1 engine were found damaged.
