**PRELIMINARY REPORT ON THE SERIOUS INCIDENT INVOLVING AN ATR 72-600 AIRCRAFT WITH NATIONALITY AND REGISTRATION MARKS 5N-GAA OPERATED BY GREEN AFRICA AIRWAYS LIMITED WHICH OCCURRED AT GENERAL TUNDE IDIAGBON INTERNATIONAL AIRPORT, (DNIL) ILORIN NIGERIA ON 24 JULY 2024**

<b>Operator:</b>	Green Africa Airways Limited, Nigeria
<b>Aircraft type and model:</b>	ATR 72-212A (600)
<b>Manufacturer :</b>	ATR-GIE Avions de Transport Régional, France
<b>Year of manufacture:</b>	2012
<b>Nationality and registration marks:</b>	5N-GAA
<b>Serial number:</b>	1057
<b>Location:</b>	Runway 05, General Tunde Idiagbon International Airport (DNIL), Ilorin
<b>Date and Time:</b>	24 July 2024 at about 12:02 h (All times in this report are local time, equivalent to UTC+1 unless otherwise stated)

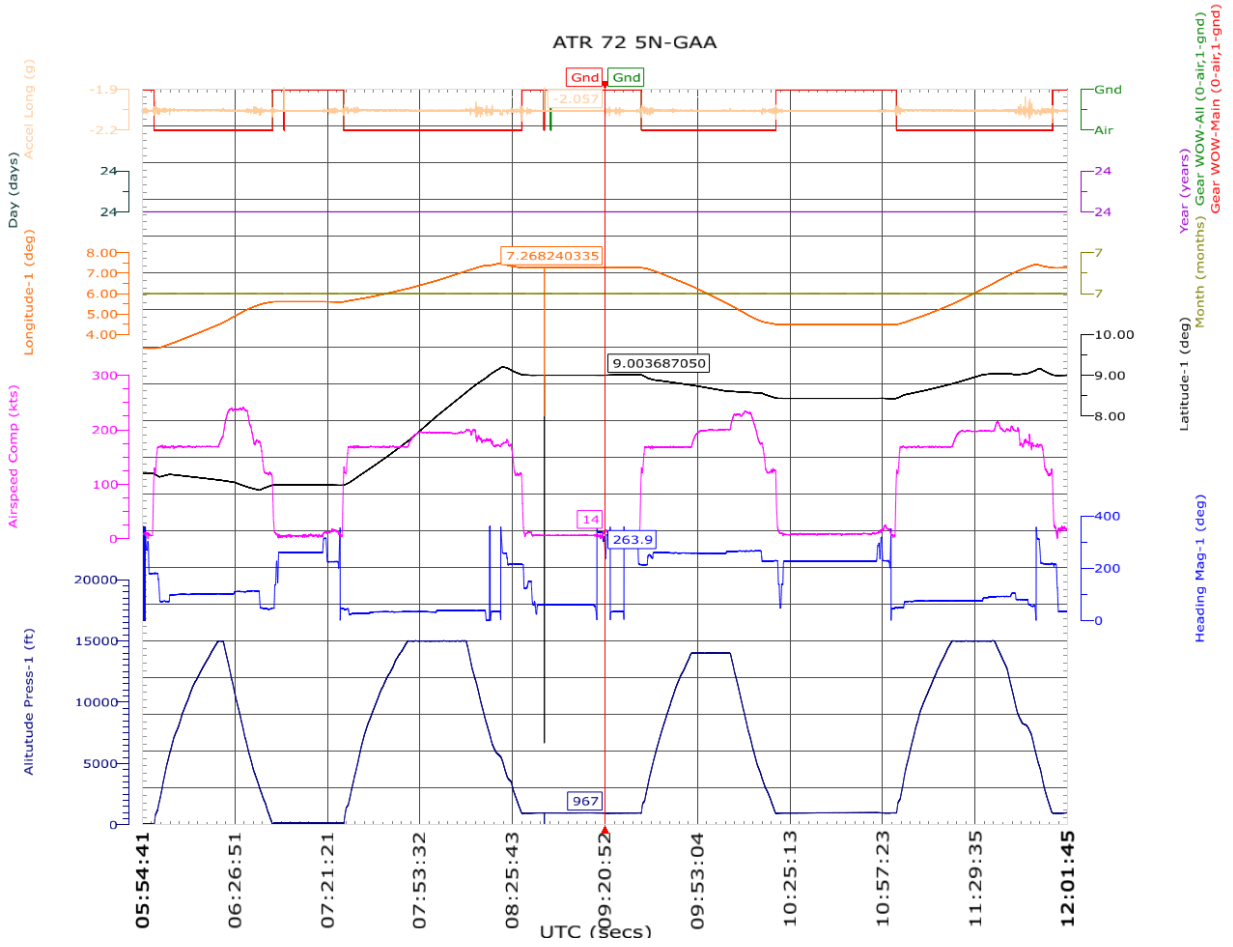
Figure 3: Profile of flights on the 24 July, 2024

The aircraft landed at 12:57:34 h, 1222 m from the threshold of Runway 22, past exit A3. The crew noted the aircraft's tendency to veer left and extended the landing roll to slow the aircraft before exiting the runway at A6, 1780 m from the touchdown point.

8. The aircraft was observed to veer left during the landing roll, and the landing roll was extended to bleed its speed before departing the runway.
9. The flight crew learned of the nose wheel detachment after parking at DNAA.
