# AIRCRAFT ACCIDENT REPORT

**Nigerian Safety Investigation Bureau**

**Final Report on Serious Incident involving Embraer  
EMB-145LR with nationality and registration marks  
5N-BVD operated by Air Peace Limited which  
occurred at Kaduna Airport, Kaduna on 14th January,  
2021**

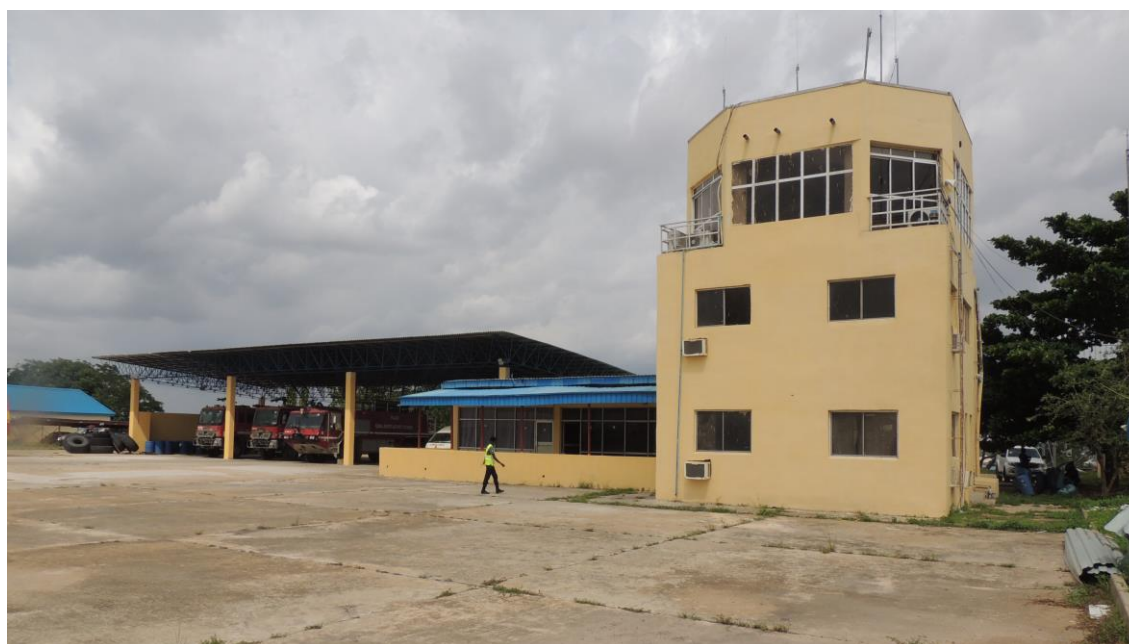
**Figure 5:** ARFFS Watch room/ATC Tower

The ARFFS was equipped with three fire tenders, one of which (E-One 21) was unserviceable at the time of occurrence.

Records indicate that the last Response Time Test was conducted in July 2018, two years prior to this occurrence and the airport does not have an approved Airport Emergency Plan.

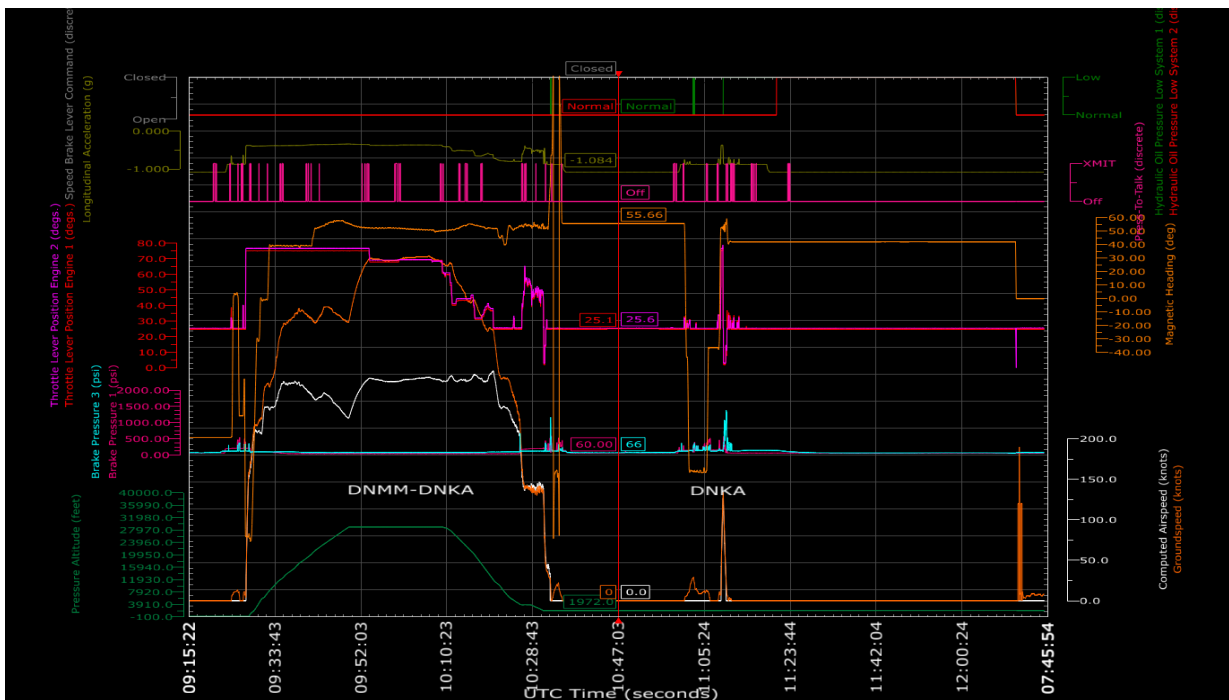
**Figure 8:** Lagos-Kaduna and aborted flight profiles

The FDR showed that the take-off was aborted at a computed airspeed of 119 kt. Thereafter, the Number 1 Thrust Reverser did not deploy and hydraulic fluid pressure for Number 1 system became low. Brake pressure was applied to bring the aircraft to a stop.
