AIRCRAFT ACCIDENT REPORT

2/2009 (BLV 2005/10/22/F)

Accident Investigation Bureau

**Report on the Accident involving
Bellview Airlines Ltd B737-200 Reg. 5N-BFN
at Lisa Village, Ogun State, Nigeria
On 22 October 2005**

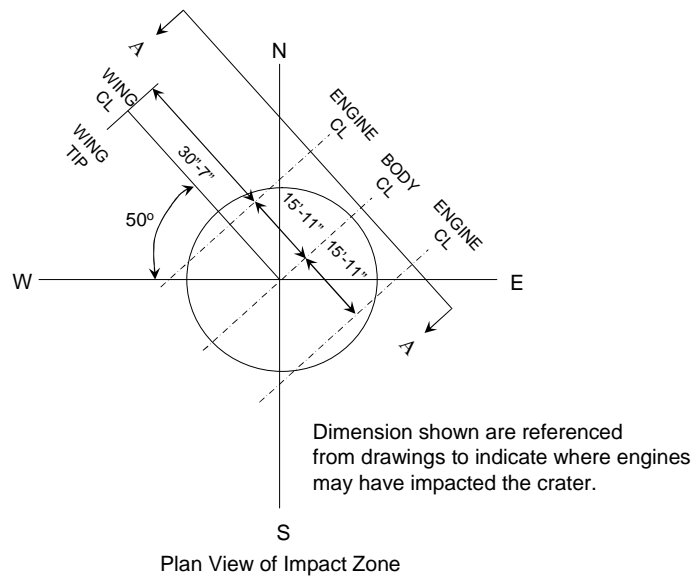
Fig 1.12a Plan view of the impact crater

Crash site showed one engine imprint on the ground at the edge of the main aircraft impact generated crater. The engine imprint appeared to be adjacent to a wing imprint.

Although it was almost vertical to the ground, the engine entry path to the ground appeared to be at an angle smaller than 90 degrees. The North direction was designated as 12 O'clock position of the main crater. The engine imprint was between 10 and 11 O'clock positions. (See fig 1.12a)

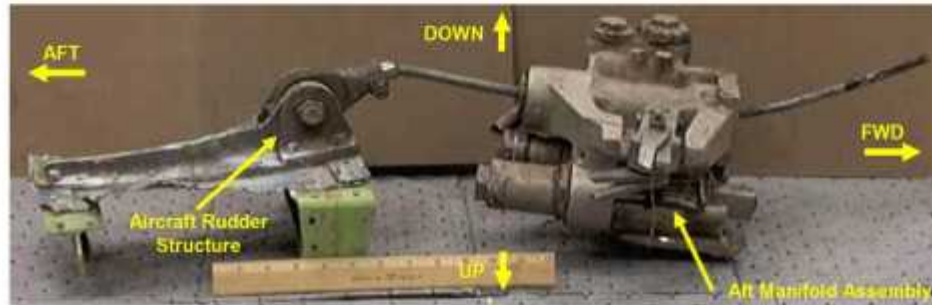
assembly, the bent, redundant piston rod extended with the rod end still attached to a segment of the aircraft rudder structure. All of the mechanical linkages that should have been attached to the aft piston rod were missing. Figure 2 documents the "as-received" condition. Figures 3 - 9 show overall photographs of the aft manifold assembly. Note that the location descriptions reference the as-installed orientation of the PCU in the aircraft.

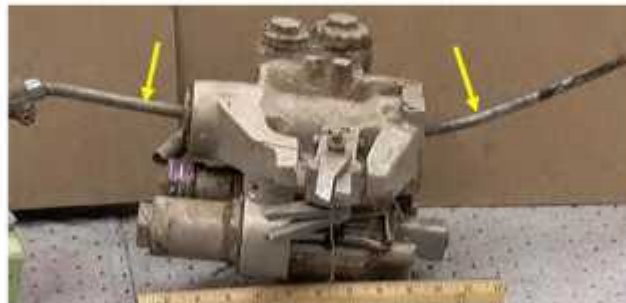
Figure 3. Left side view showing bent, redundant piston rod

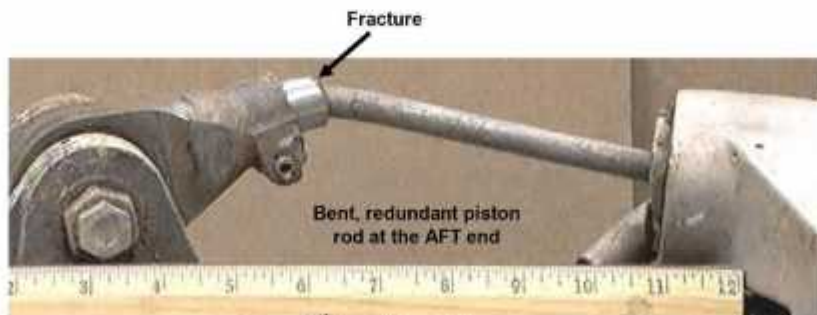
Figure 10

Figures 10 – 16 document the anomalous features of the piston rod at the **AFT** end of the subject PCU. Note that the bend and fracture (cup/cone tensile type) are at the attachment point. Note also in Figures 14 and 15 that the mating surface of the fracture shown in Figures 12 and 13 appears to be recessed in the (gland) nut.

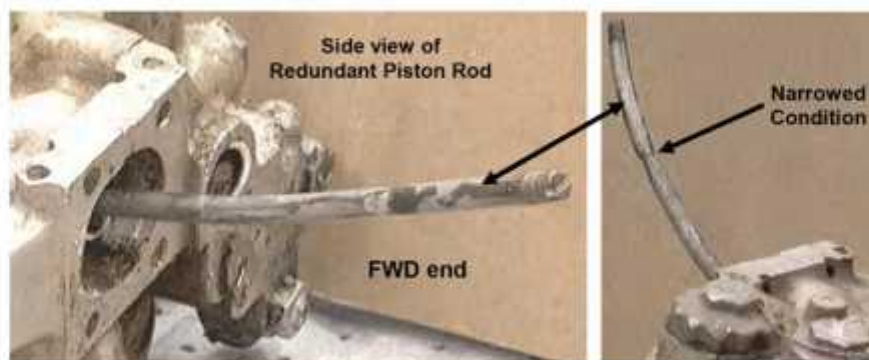
Figures 17 – 21 document the anomalous features of the piston rod at the **FWD** end of the subject PCU. Note the narrowed condition of the rod in Figure 19.

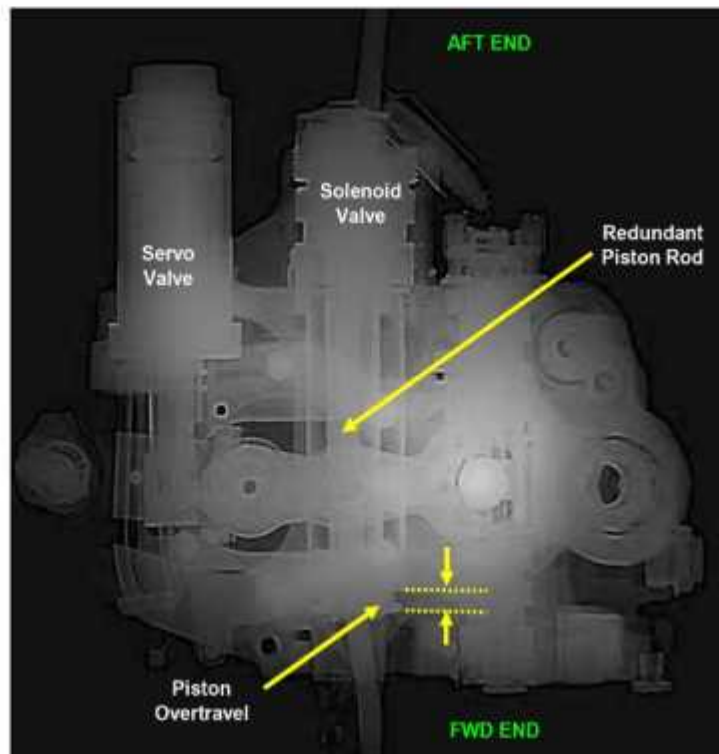
The subject PCU was then transported to the Boeing Non-Destructive Test (NDT) facility for x-ray imaging, including computed tomography (CT). Prior to transport, the aircraft rudder structure attached to the rod eye (at the **AFT** end) was removed. X-ray images were taken that revealed a bowed redundant piston rod, which extended throughout the entire body of the PCU. Additionally, the over-travel of the aft piston was quite visible. Figure 32 shows a representative image and points out both of these two features.

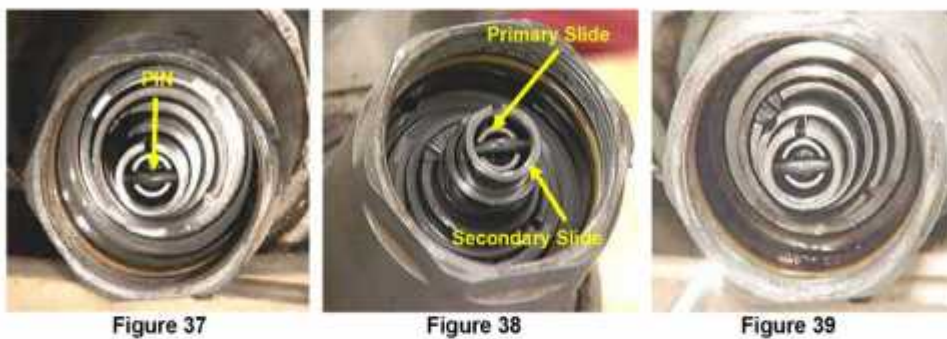
Next, the cap of the servo valve was removed, revealing both the primary and secondary slides. Two springs along with the spring guides (single & double) were removed. During this disassembly, it was noted that the spring keeper pin was broken. Figures 37 – 40 document this activity.

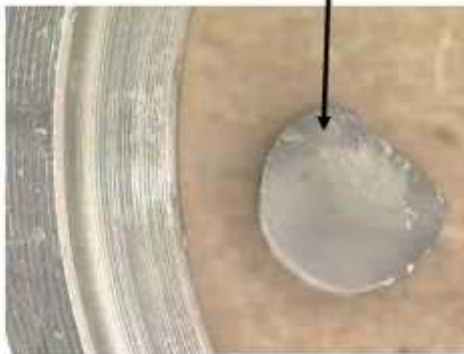
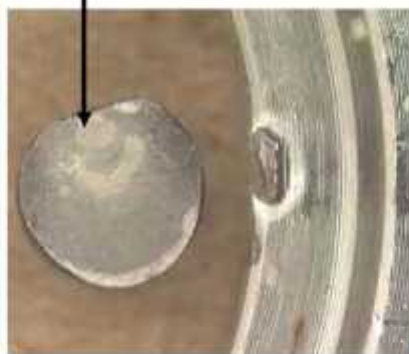
Figures 41, 42 and 43 show the single spring guide and the two end pieces of the fractured spring keeper pin.

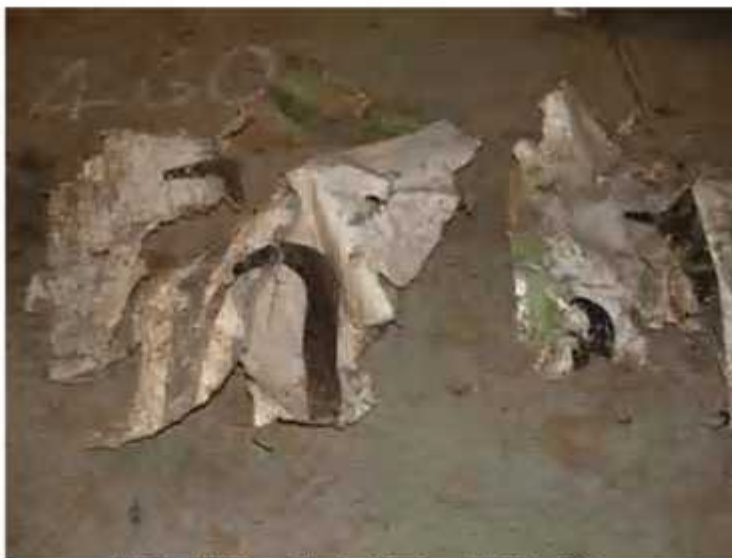
Going forward a portion of the left skin containing "Bellview" was recovered. This is between BS 440 and about 580 above stringer 10 on both sides of the airplane.

FIG 5 – Skin Pieces That Include Part of Bellview’s Name
(This shows the portion with “bel”)

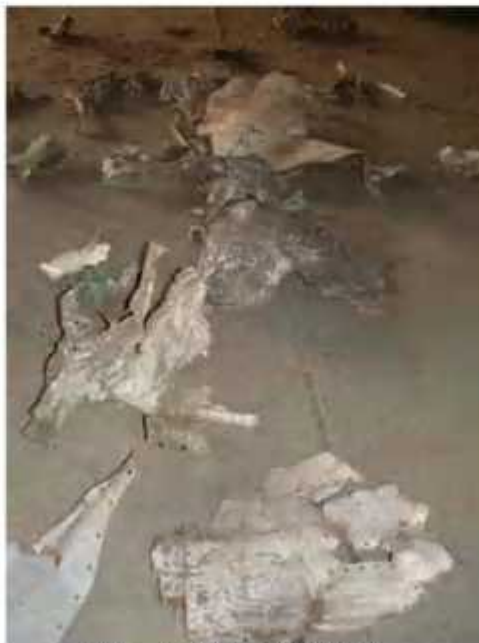
The next significant skin section is located at the BS 360 splice. There are portions from stringer 6L to 10L (aft of 360), 12L to 15L (aft of 360), 16L to 18L (fwd of 360) including the aft lower corner of the entry door cutout, and 17L to 19L (aft of 360).

FIG 6 – Left Skin at BS 360 Splice

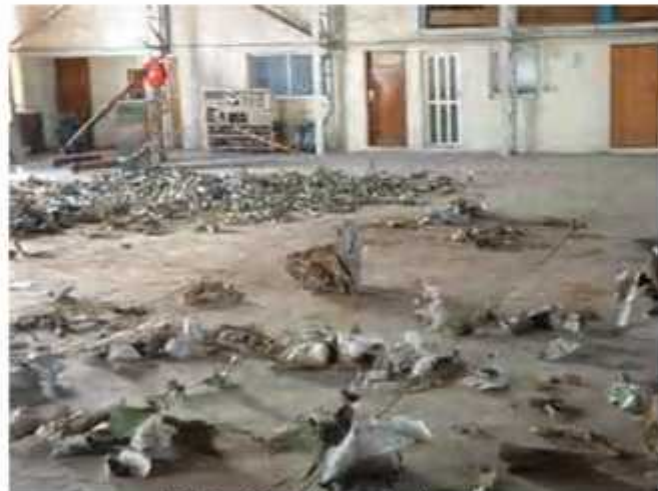
FIG 10 – Miscellaneous Fuselage Parts

A number of skin pieces remained unidentified as to their location. A large example of one of these is shown in figures 9 and 10.

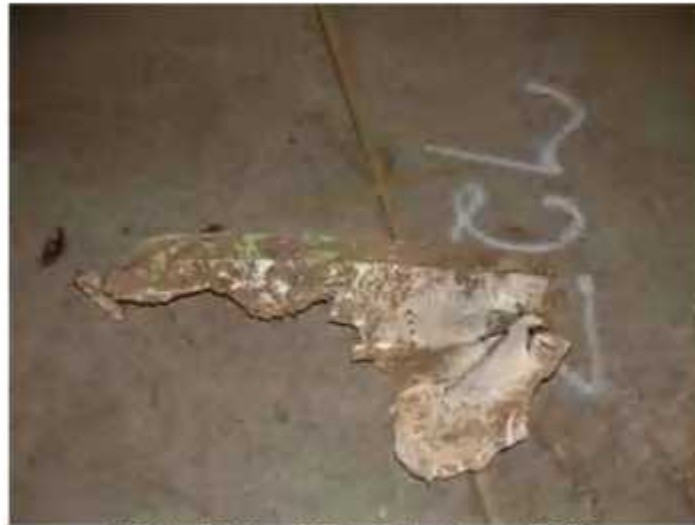
FIG 11 – BS 540 or 727 Butt Splice (shown at BS 727)

There were a few pieces from either the BS 540 or BS 727 butt splice, but no obvious details that indicate positive identity.

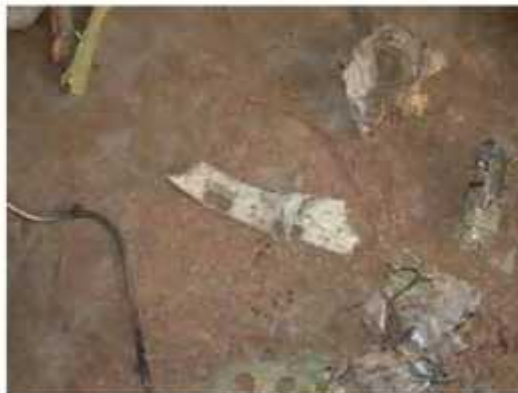
FIG 12 – Typical Floorbeam

The floorbeams the width of the fuselage and provide support to both the cabin floor as well as the pressure loads induced into the frames. Like the frames, the floorbeams are spaced approximately every 20” throughout the length of the fuselage. An examination of the wreckage located only one short section of floorbeam.

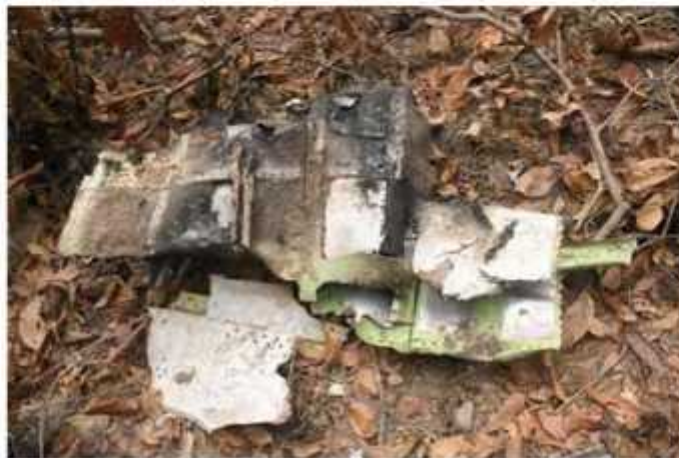
During the examination of the impact site, a number of parts were noted to have evidence of burn damage (actual heat and sooting). A section of recovered fuselage skin from approximately body station 940 to 980, left side (below the windows and on the backside of the body registration number) appeared to display an unusual burn/sooting pattern. As noted on the accident site, the part was folded twice, the outside against outside and inside against inside. The burn/sooting pattern appears to stop along the fold line. The level of expertise available at the site could not make a determination of pre- or post- impact fire damage.

FIG 13A – Burned Part at Site – Opposite Side

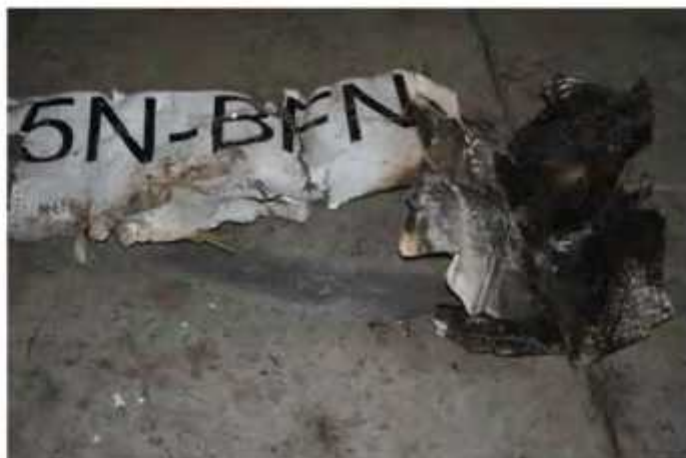
FIG 13C – Burned Part Unfolded at Hanger (airplane exterior)

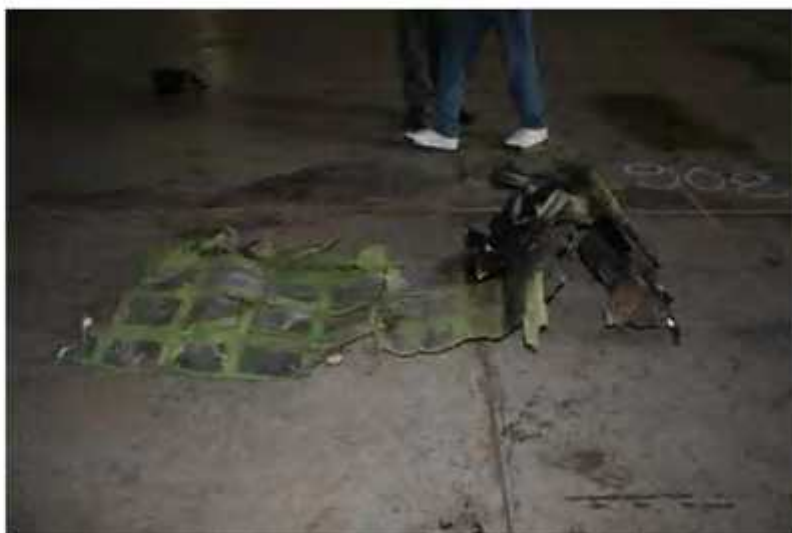
FIG 13D – Burned Part Unfolded at Hanger (cabin side)

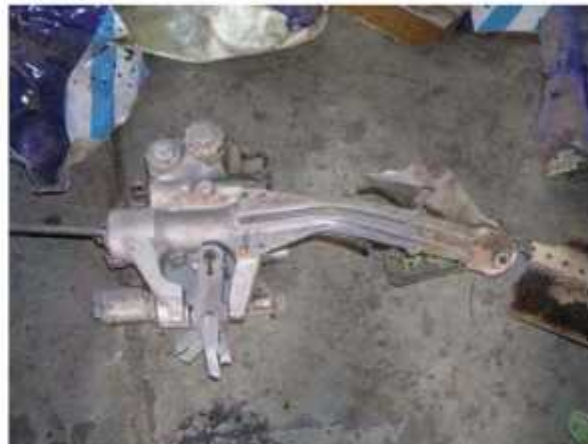
- Rudder System (Main Rudder Power Control Unit (PCU))
 This unit, shown in figure 14 (as documented in the field), is missing the front portion of the attach arms which provide support to the vertical stabilizer rear spar. The inner portion of the concentric dual piston remains attached to the rod end; this, in turn, remained attached to a portion of the rudder front spar. Figure 15 shows the unit in the hanger with a recovered portion of the attach arms.

FIG 15 – Main Rudder PCU (in hanger with recovered forward support arm)

The exposed piston measures 10.5” in length. It is jammed in position. The input lever can be moved.

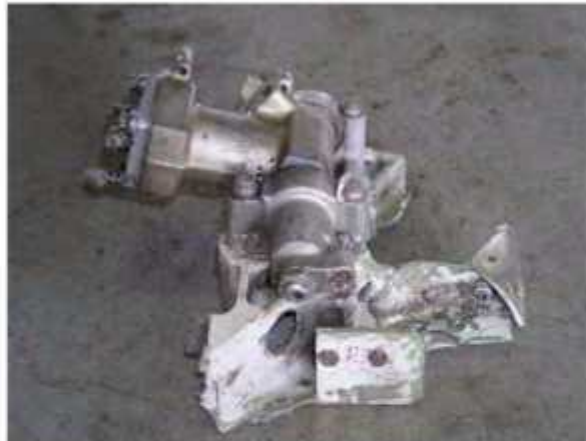
FIG 16 – Spoiler Actuator

No identifiable components of the aileron control or actuation system were recovered. Small portions of the aileron surface were recovered. Portions of the spoiler panel structure and skin were also recovered. One spoiler actuator was recovered as seen below in figure 16.

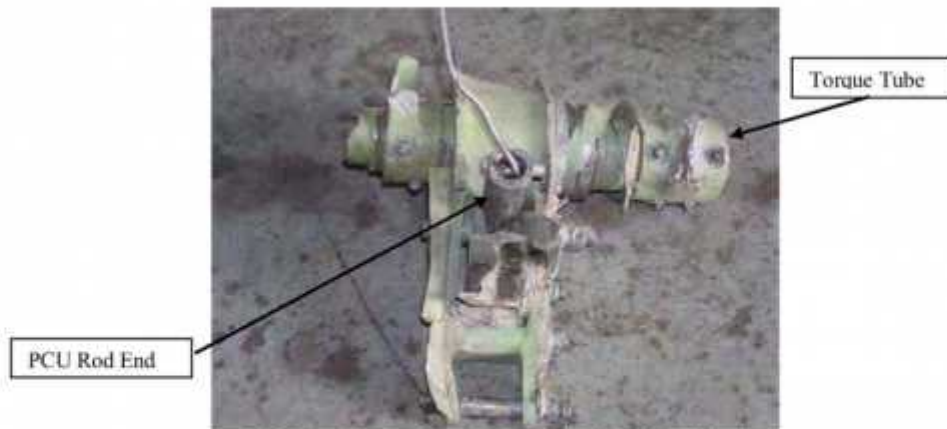
As well, a small portion of one side of the elevator input torque tube was recovered. This portion still has the rod end of the elevator Power Control Unit attached to it. See figure 18.

FIG 18 – Elevator Input Torque Tube & PCU Rod End

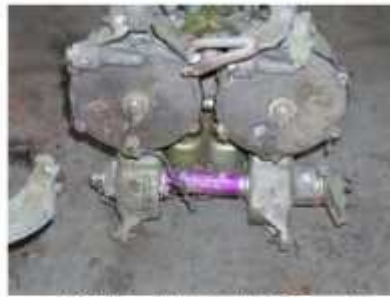
FIG 20A – Elevator Feel Computer

In addition, the Feel Computer and one (of two) elevator tab lock mechanisms were found. The feel computer is largely intact and is fractured from its mounting hardware; the tab lock mechanism has the actuator and the moving arms but is missing the springs and the actual tab rods which connect to and drive the tab during airplane manual reversion. Figures 20A and 20B show these two components, respectively.

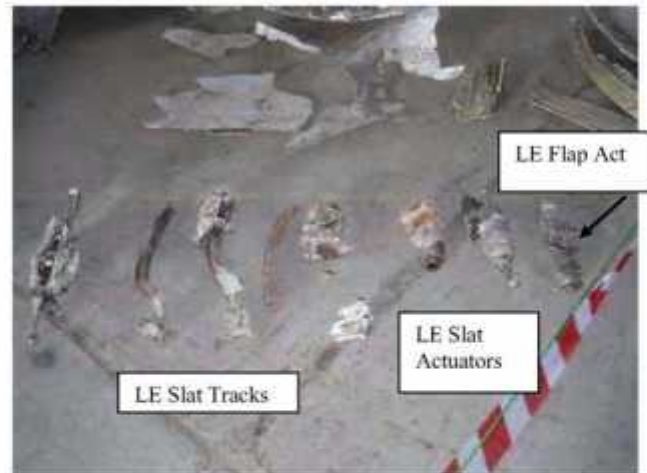
FIG 2A1 – LE Devices

The high lift system consists of the wing leading edge and trailing edge devices. Wing leading edge devices consist of 6 slat actuators and 4 kruger flap actuators. There are 12 leading edge support tracks. Wing trailing edge devices consist of 8 flap transmissions and tracks. As noted in figures 21A, recovered high lift components include 2 LE slat actuators, 1 kruger flap actuator, and 5 LE slat tracks.

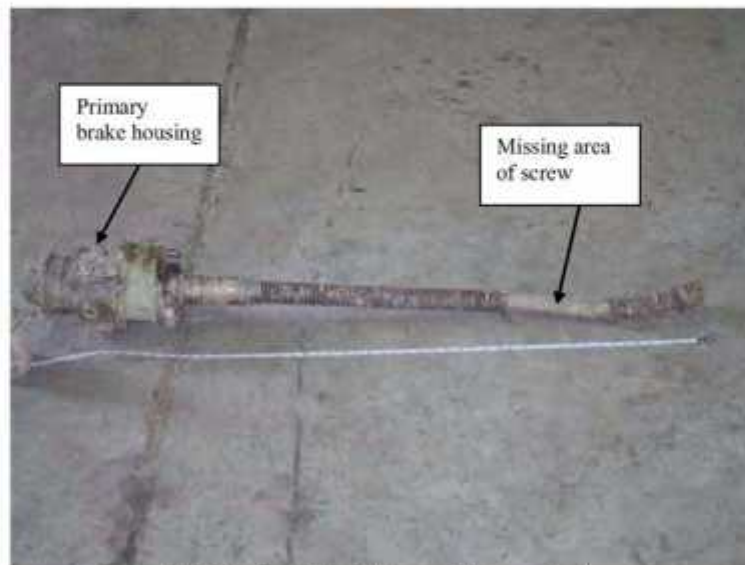
FIG 22 – Stab Trim Ballscrew & Primary Brake

The main system component normally consists of a large transmission with primary and secondary brake, two motors, and a cable drum. A 4' long ballscrew extends from the transmission housing and rotates causing the horizontal stabilizer to move to the commanded position. The only component recovered is the ball screw and primary brake assembly as shown in figure 22

The screw assembly normally consists of the ballscrew and an inner safety rod. Figure 22 notes an 8" section of the outer ballscrew missing. This is also a fracture point for the inner safety rod. This missing area is consistent with the size of the stabilizer ballnut. This indicates that, based on a measurement of the screw length between the lower surface of the upper stop and the point of fracture for the screw that the stab trim held a position of 4.2 units (1.2° LE down).

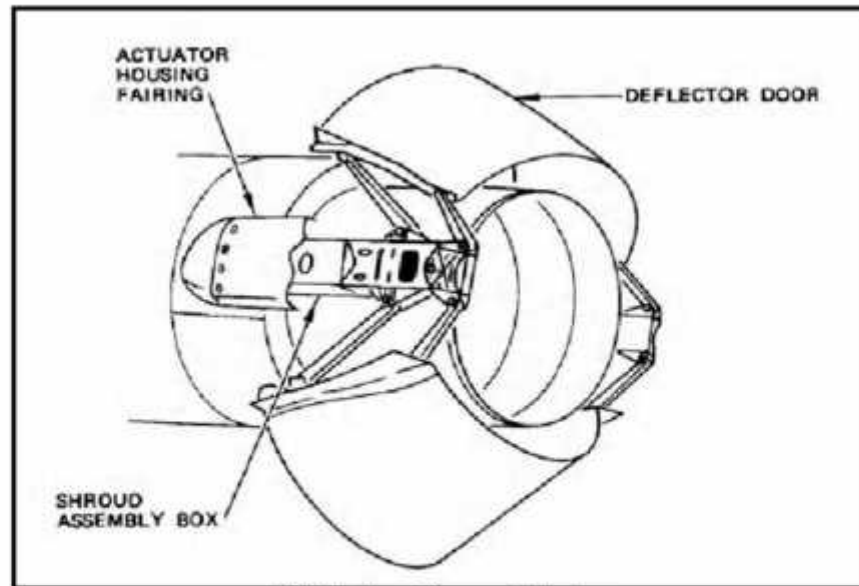
FIG 24 – Thrust Reverser Mechanism

The JT8D thrust reverser system consists of two clamshell type doors which are used to redirect the engine exhaust thrust. Each door has a separate lock and actuation system. The main actuation mechanism for both door-pairs were recovered as was one lock actuator and two lock latches (there are normally 4 lock systems). Figure 24 below shows the reverser mechanism.

Portions of all four actuation mechanisms were recovered. These portions consist mainly of the links and driver assembly. One partial cylinder (of 4) hydraulic actuators was found.

Two of the four mechanisms were noted to be in a deployed or partially deployed position. Further examination resulted in locating each pair of mechanisms. Of each pair, one mechanism was found in the stowed position whilst the other is noted to be in the deployed or partially deployed position. Further examination is necessary.

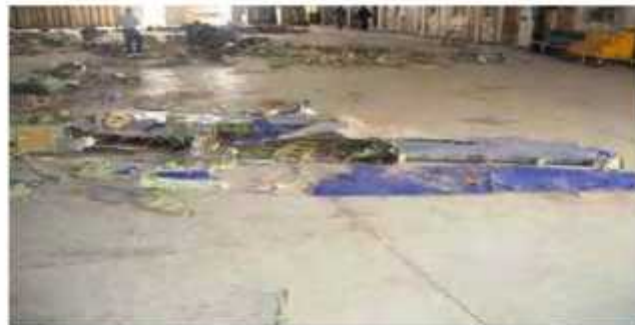
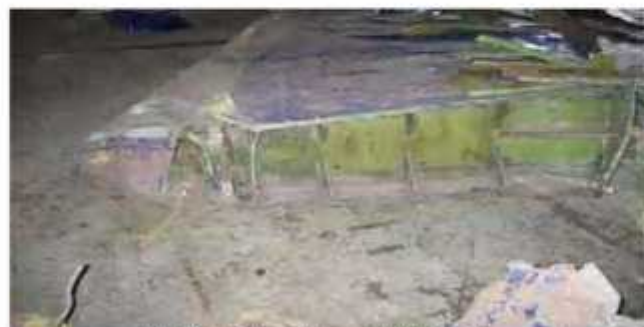
Approximately 75 percent of right hand horizontal stabilizer has been recovered. Stabilizer is in two large and two small assemblies and number of small pieces.

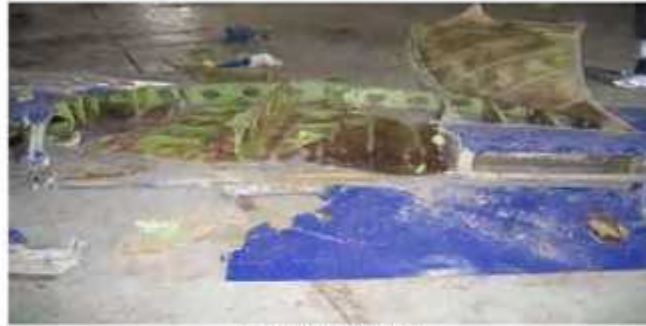
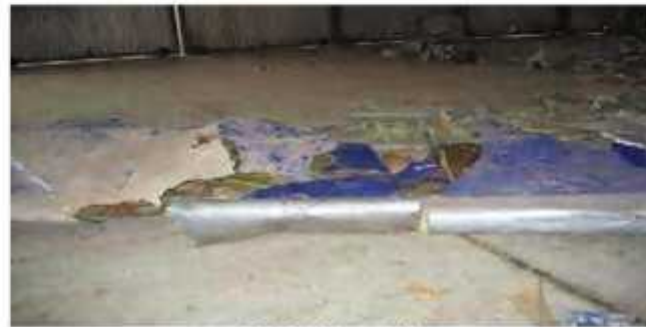
Upper skin is in two large pieces and two small pieces with some missing section. There are number of tears in the skin.

Second tear is at outboard of SSta 147.90 going fwd-outboard to SSta 164.

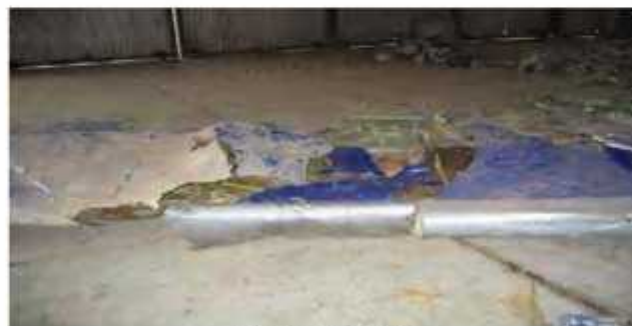
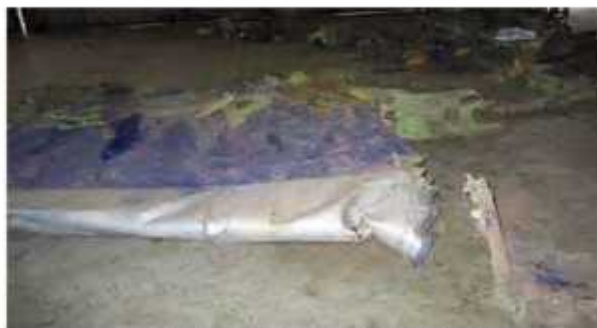
Inboard to LESta 142.45
LESta 142.45 to LESta 176
Section from LESta 176 to LESta 193 is missing

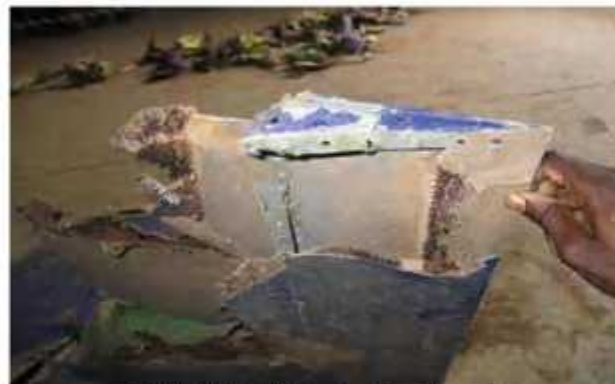
Two large pieces of elevators were recovered. The inboard section from outboard tab cutout location to inboard section of elevator is missing. All attachments of elevator to stabilizer were broken.

FIG 31A Edge of elevator at the tab cutout

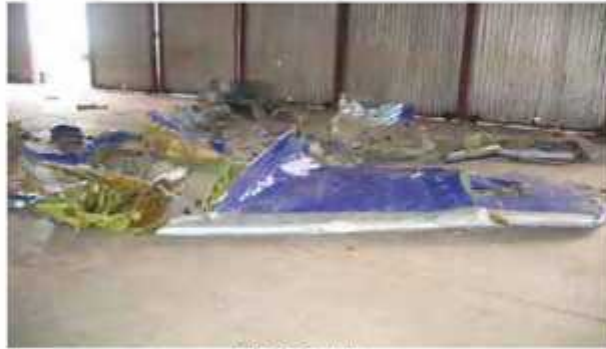
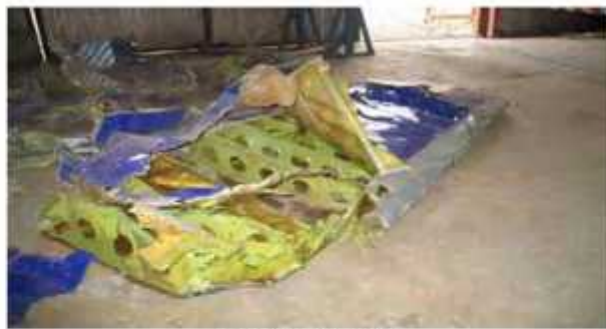
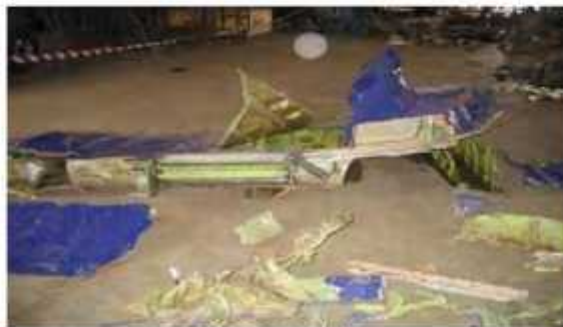
Approximately 35 percent of left hand horizontal stabilizer has been recovered. Stabilizer is in three large assemblies and number of pieces.

The inboard section of the stabilizer is missing (approximately 1/3 of stabilizer). The mid section crushed and tangled.

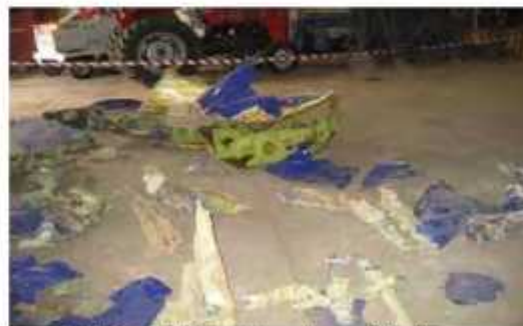
Some upper/lower inboard skins were recovered.

FIG 33A Stabilizer Upper/Lower Skin Pieces

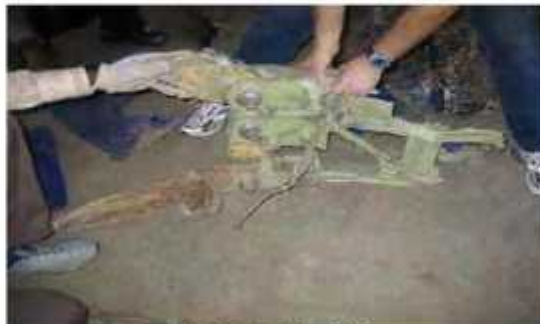
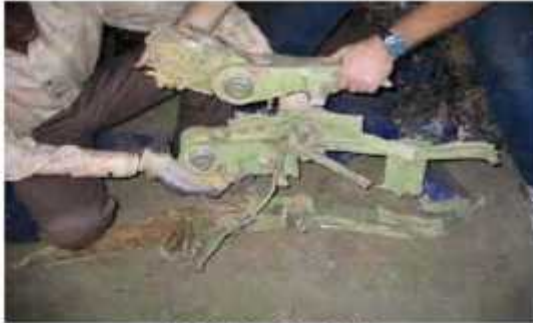
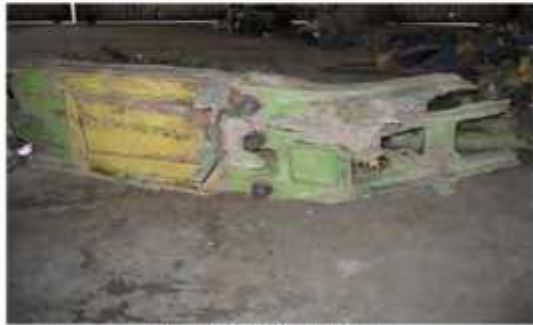
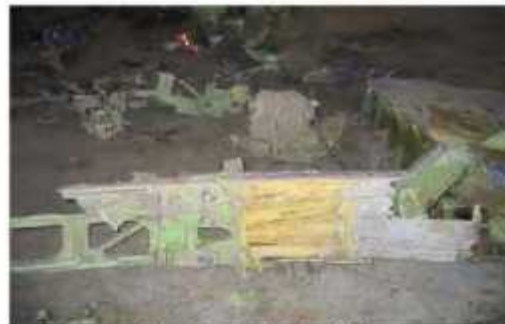
Very small parts of center section rear spar were discovered. The sections found were both right hand and left hand section with part of inboard section of horizontal stabilizer rear spar attached together. Left hand side was in three pieces. All bolts (6) were in place and tight.

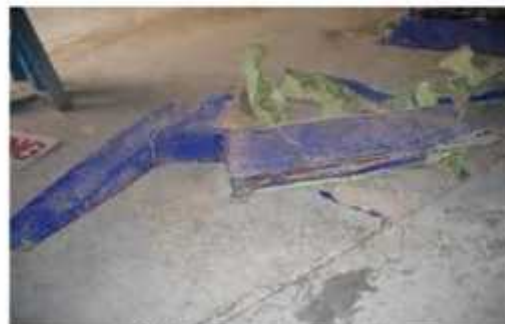
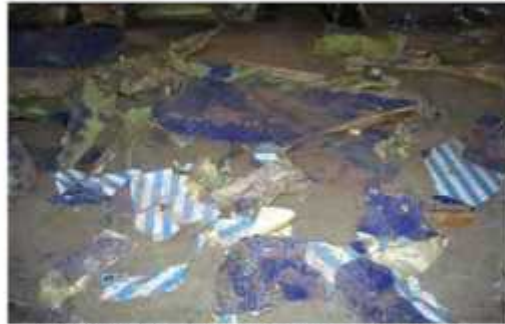
Upper 1/6 section of upper vertical stabilizer section plus some of the lower section skin were recovered. No major lower sections were recovered.

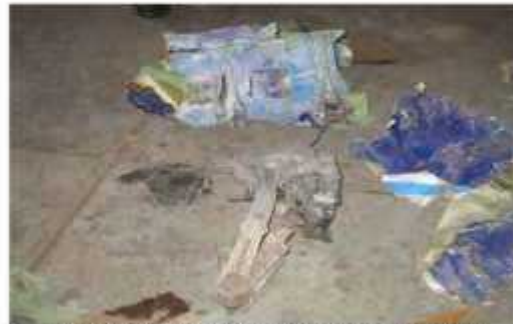
FIG 42 Rudder PCU Attached Fittings with PCU

Other rudder to vertical stabilizer attachment fittings

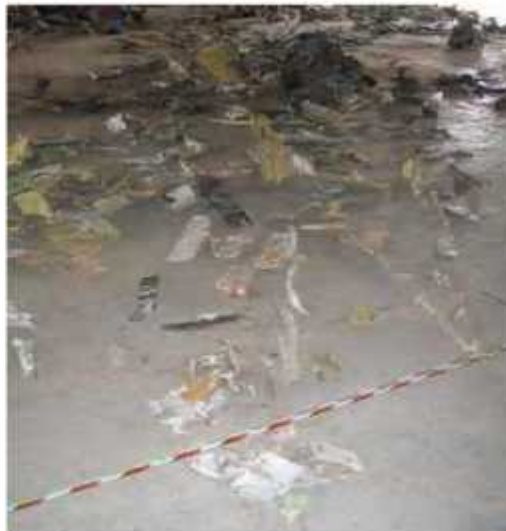
Nearly all the airplane's recovered wing parts were fractured in small pieces. Pieces were found from LH wing tip to RH wing tip. Local fire and/or smoke damage RH WBL 415.93 trailing edge rib, and trailing edge structure at various locations. No melted aluminum found.

FIG 44 General overview of a 2D layout of the RH wing looking inboard from the wing tip.

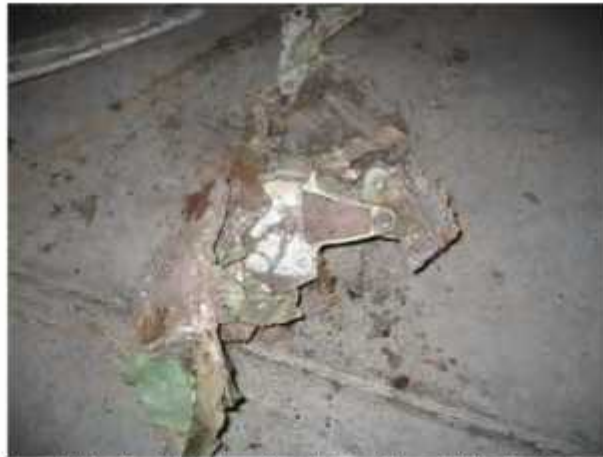
- 1 of 8 (total per airplane) fixed trailing edge aileron hinge fittings (ref D6-15897 pg 54). With partial aileron attached.

FIG 45 Side View of 1 fixed trailing edge aileron hinge fitting. (WBL location unknown) (ref D6-15897 pg 54). Hinge rib and portion of the wing rear spar is shown. Portion of the aileron is shown on the right side.

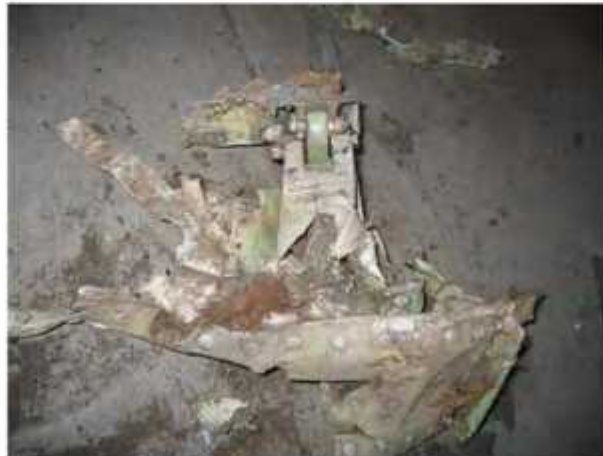
FIG 45A Plan View of the hinge shown in Fig. 2. Fixed trailing edge aileron hinge fitting. (ref D6-15897 pg 54).

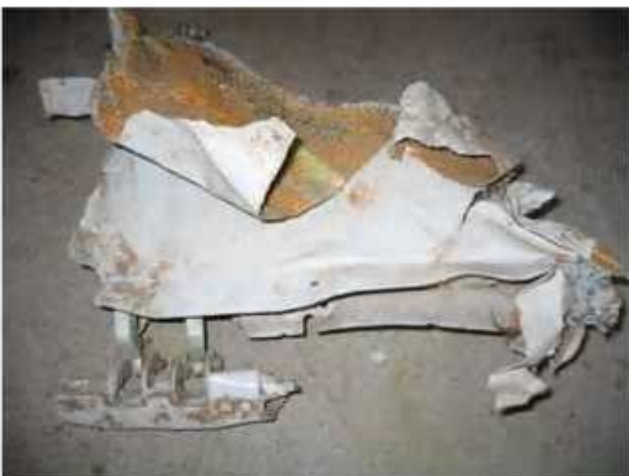
- RH aileron partial - containing tab push rods and tab mast fitting.

FIG 46 Plan View RH aileron partial - containing tab push rods and tab mast fitting.

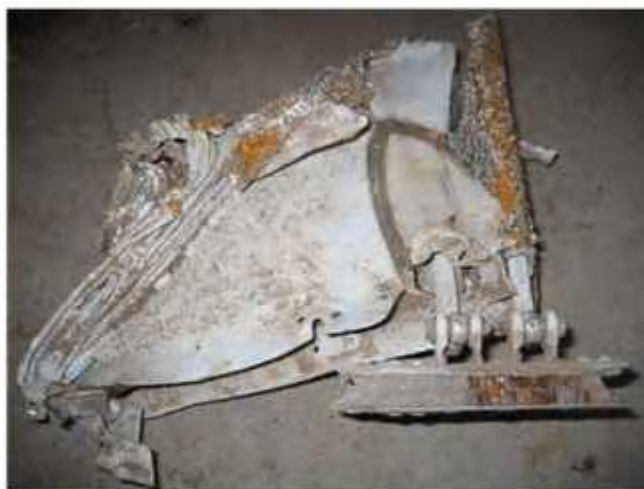
FIG 46A Bottom View RH aileron partial - containing tab push rods and tab mast fitting.

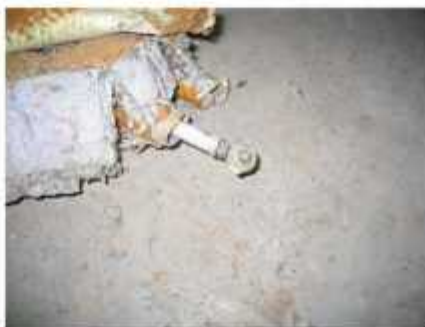
FIG 46B Aux View RH aileron (partial) - containing tab push rods at forward end.

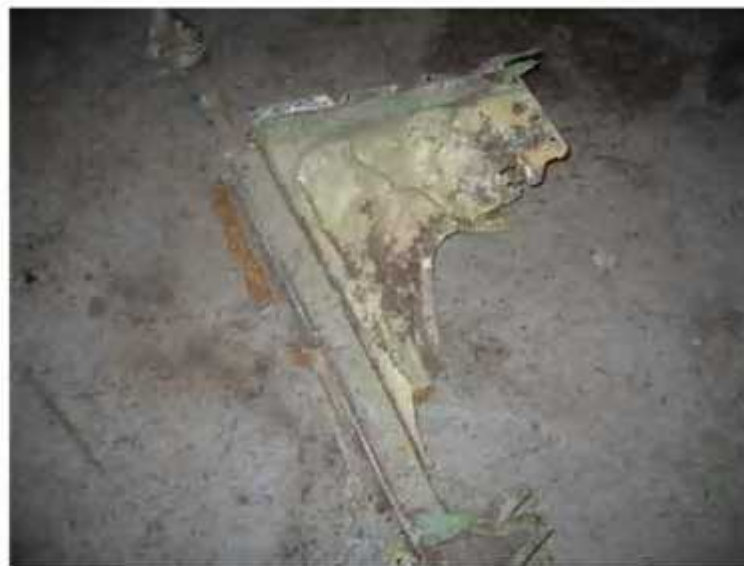
FIG 47B Plan View LH wing tip lower skin with rear spar lower chord horizontal flange shown on the left.

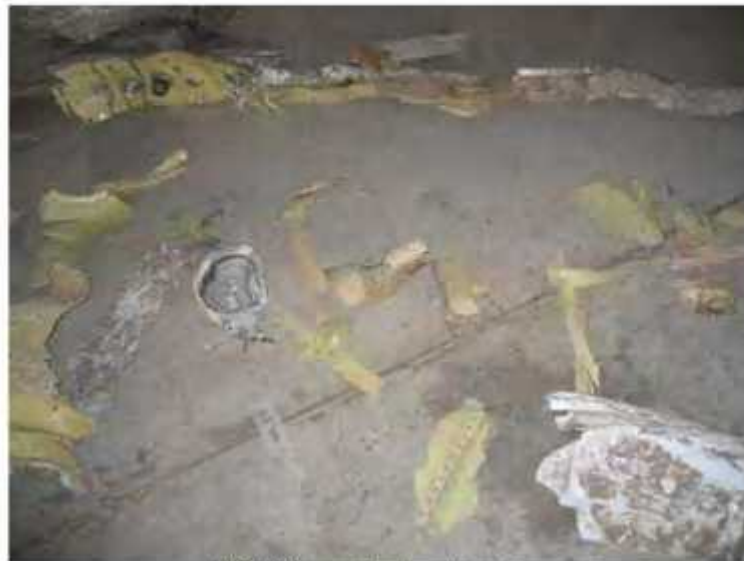
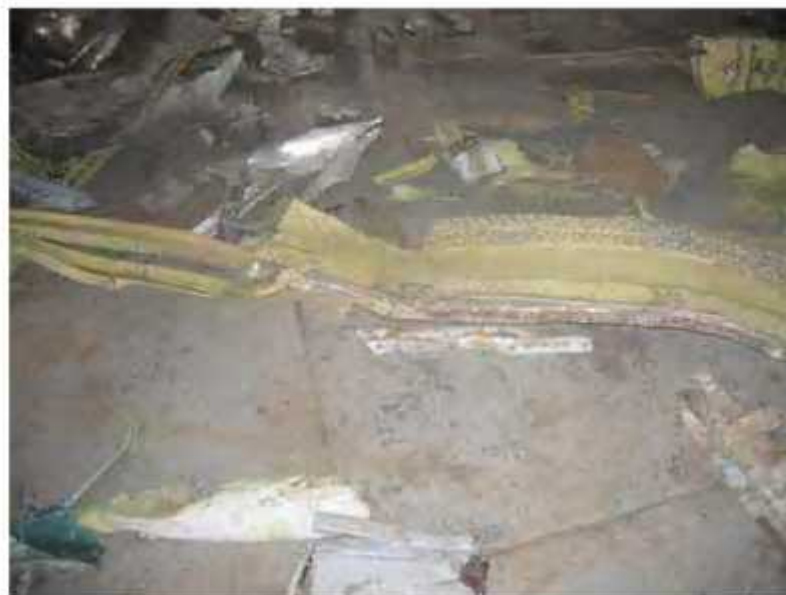
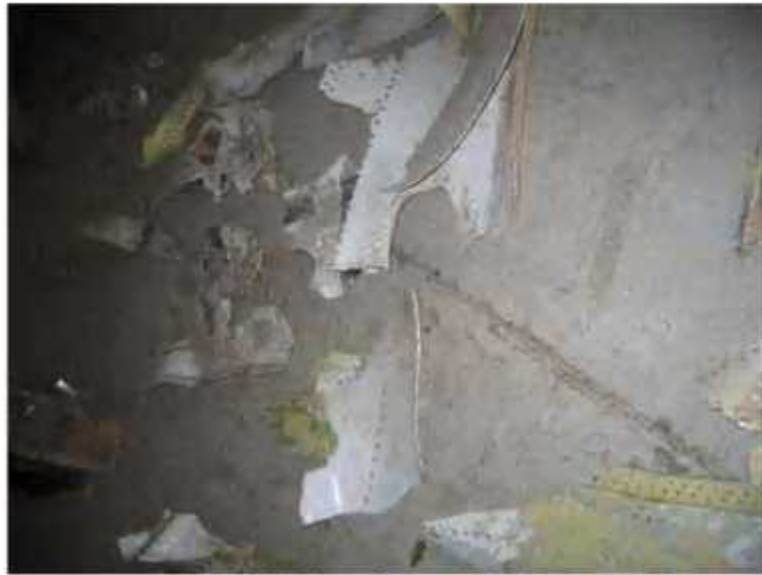
- LH and RH wing box structure from tip to side of body - partial with front and rear spars - partial and upper and lower wing skin assys (ref D6-15897 pg 44 – 44.3).

FIG 48 Pieces of outboard wing box.

FIG 48A Pieces of outboard wing box.

FIG 48B Pieces of outboard wing box.

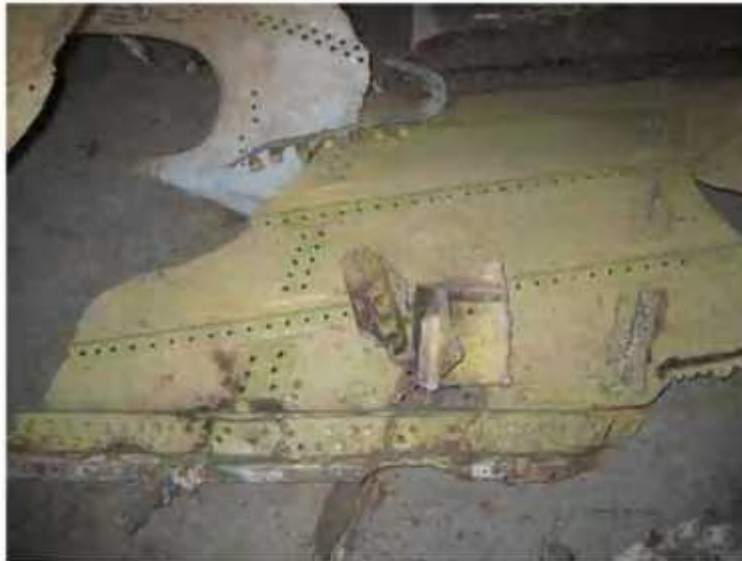
FIG 48C Pieces of LH outboard wing box lower skin at WBL 103 and rear spar. View looking down and forward.

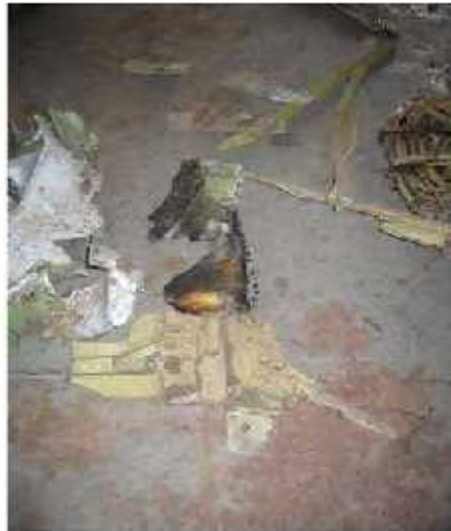
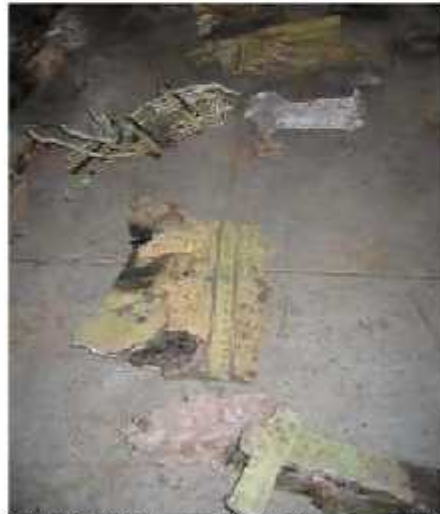
- LH and RH side of body splice - partial lower splice including some stringer end fittings. (ref BBL 70.85).

FIG 49 RBL 70.85 lower splice looking down and forward

FIG 49A LBL 70.85 lower splice looking down and forward

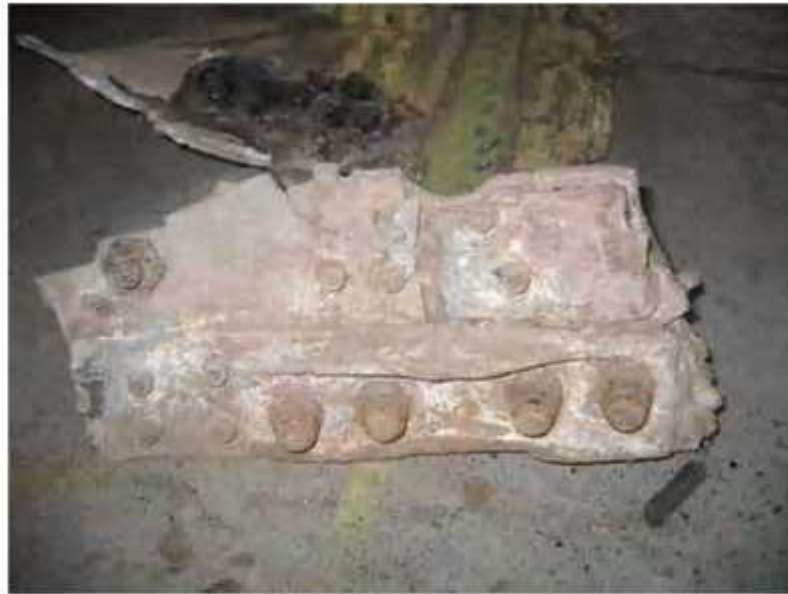
FIG 49B LBL 70.85 lower rear spar chord splice looking down and forward

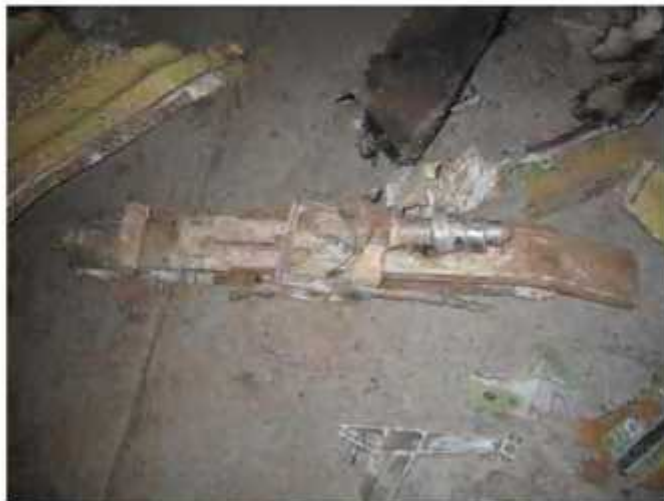
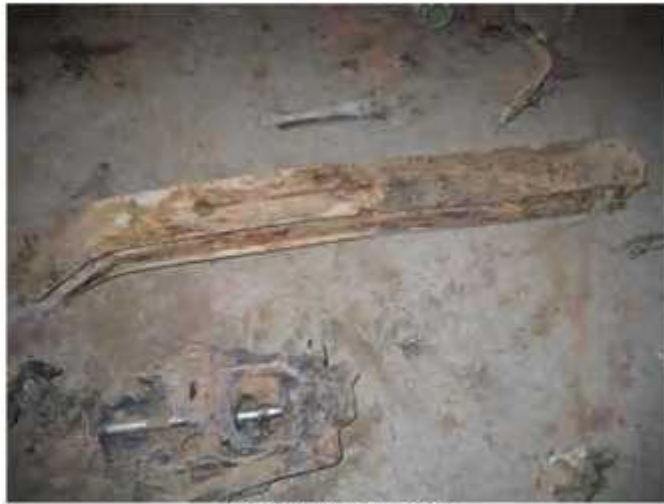
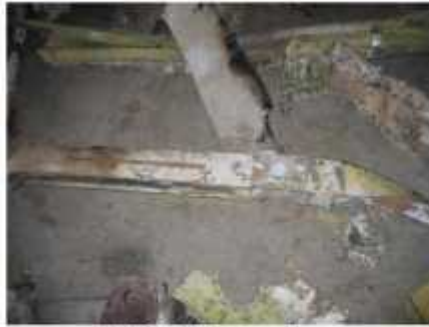
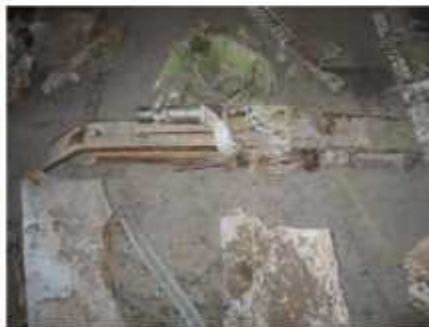
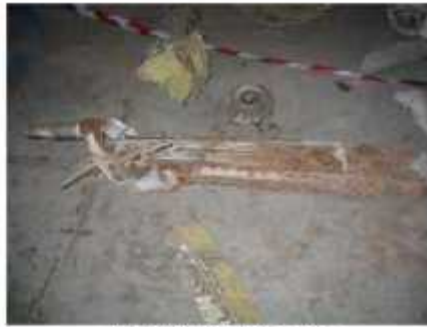
- Fixed trailing edge flap tracks 5 out of 8 were found (1, 2, 3, 6, 7 or 8).

FIG 50 Track no. 7 or 8

FIG 50A Track no. 3 or 6

FIG 50B Track no. 3 or 6

FIG 50C Track no. 1 or 2

FIG 50D Track no.1 or 2

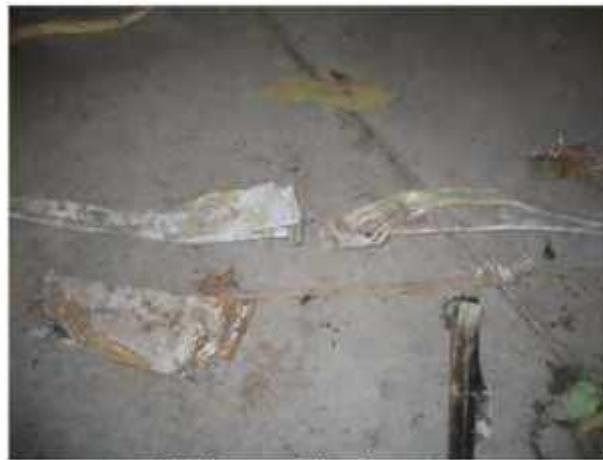
- Fixed trailing edge panels partial LH or RH between WBL 415.93 and WBL 560. (ref D6-15897 pg 56).

FIG 51 upper trailing edge panels.

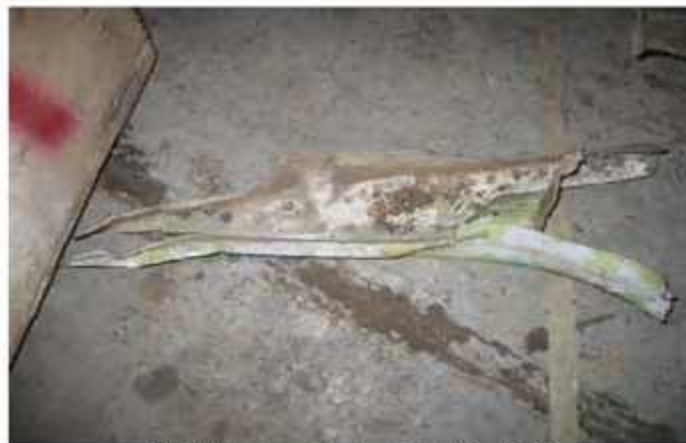
FIG 51A trailing edge rib at LH WBL 415.93.

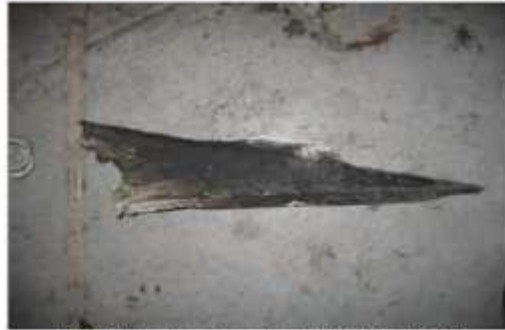
FIG 51B trailing edge rib at RH WBL 415.93.

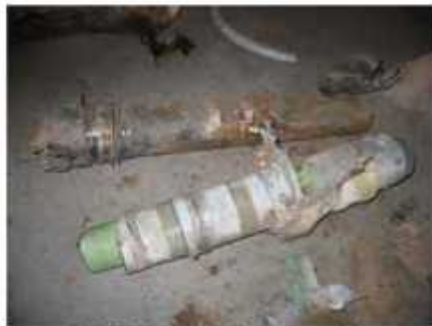
FIG 52A Inboard flap torque tubes

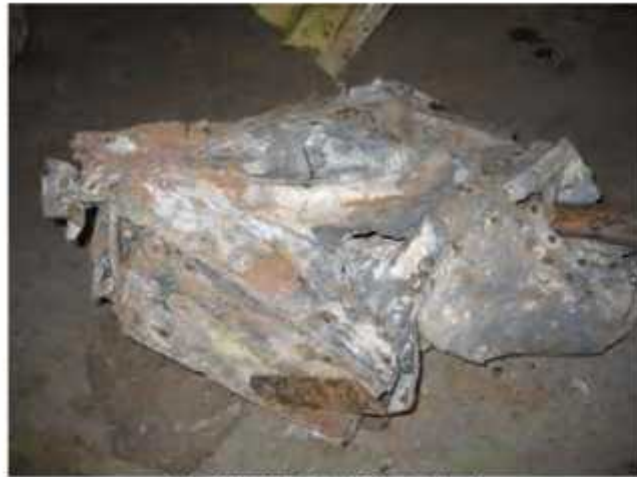
FIG 52B RH inbd midflap inbd end

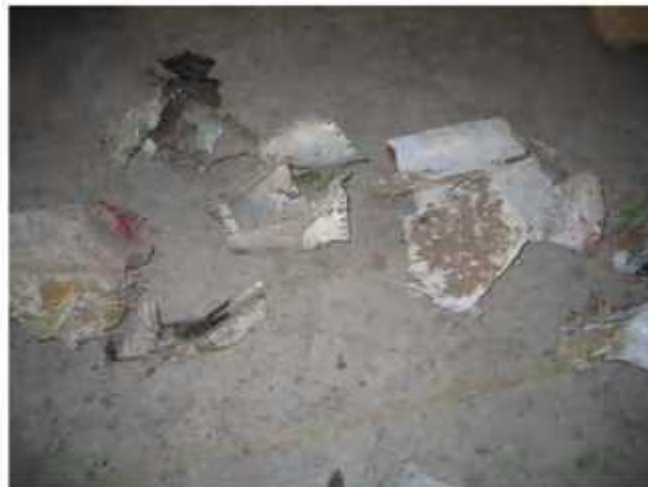
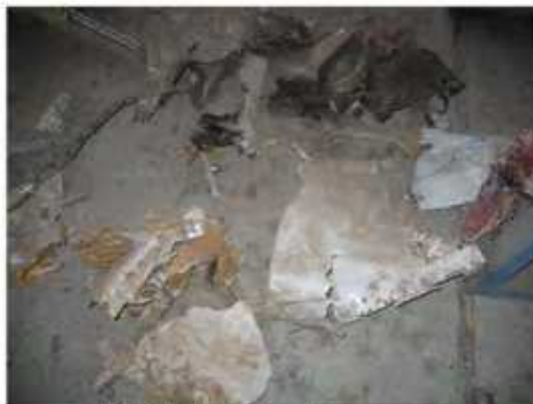
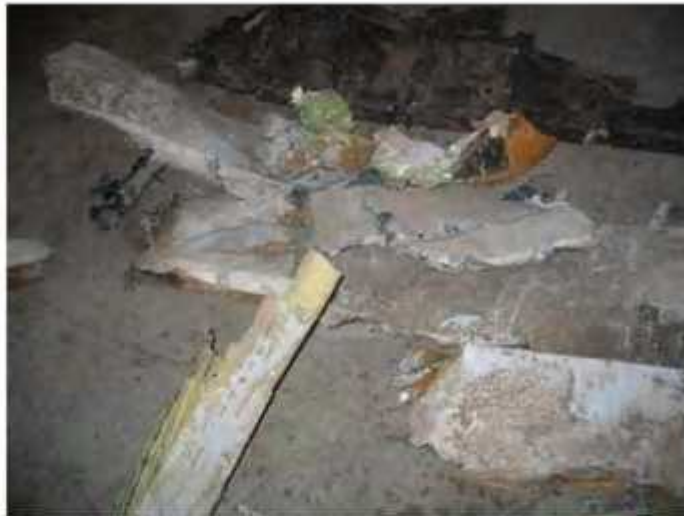
FIG 52C Flap and Spoiler components

FIG 52D Flap and Spoiler components

FIG 52E Flap and Spoiler components

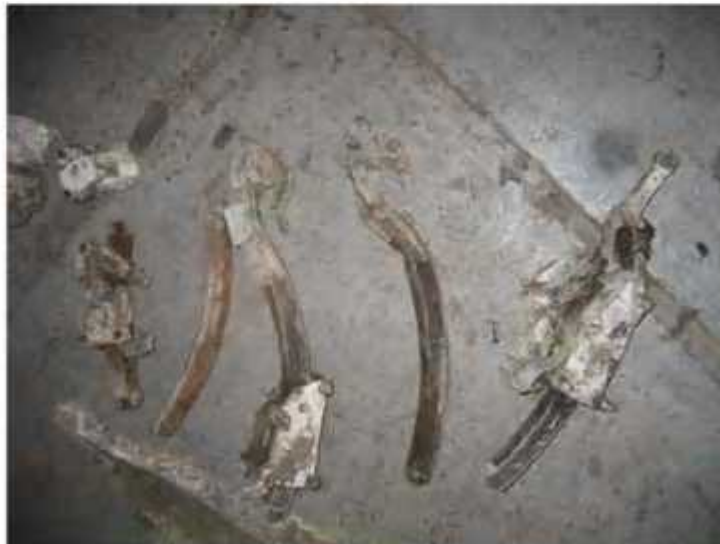
- Small pieces of leading edge, slats, and K-flaps (ref D6-15897 pg 49-52).

FIG 53 Slat tracks and fixed leading edge roller ribs
