AIRCRAFT ACCIDENT REPORT

2/2009 (BLV 2005/10/22/F)

Accident Investigation Bureau

**Report on the Accident involving
Bellview Airlines Ltd B737-200 Reg. 5N-BFN
at Lisa Village, Ogun State, Nigeria
On 22 October 2005**

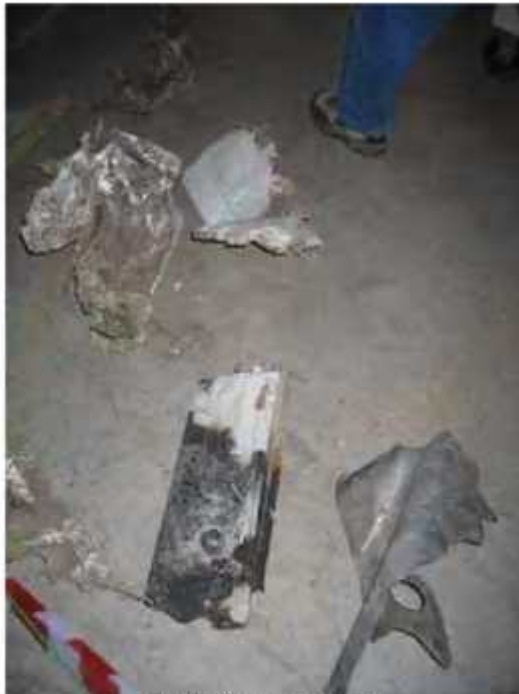
FIG 53A Slat components

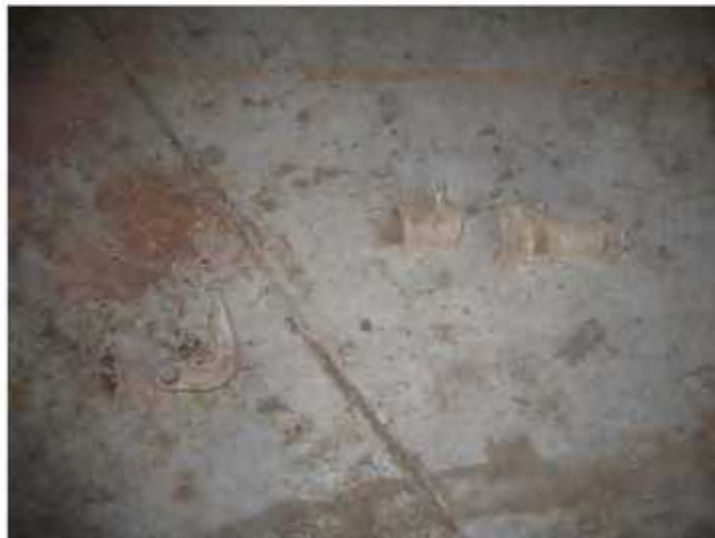
FIG 53B Krueger flap partial

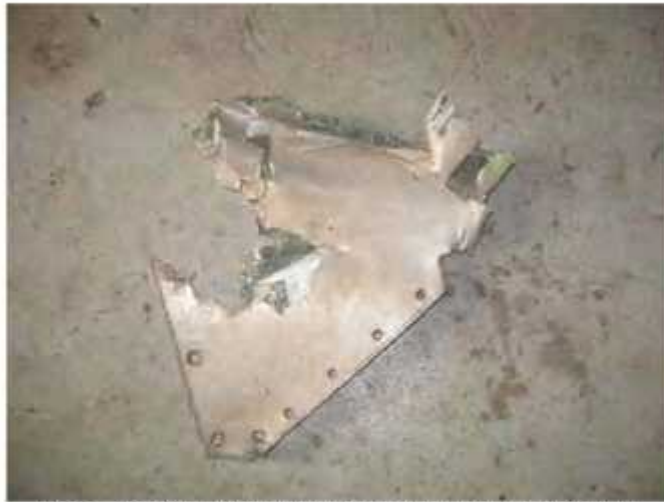
FIG 54 - 65-49541 Wing Leading Edge Access Panel at the Nacelle.
(Upper Leading Edge).

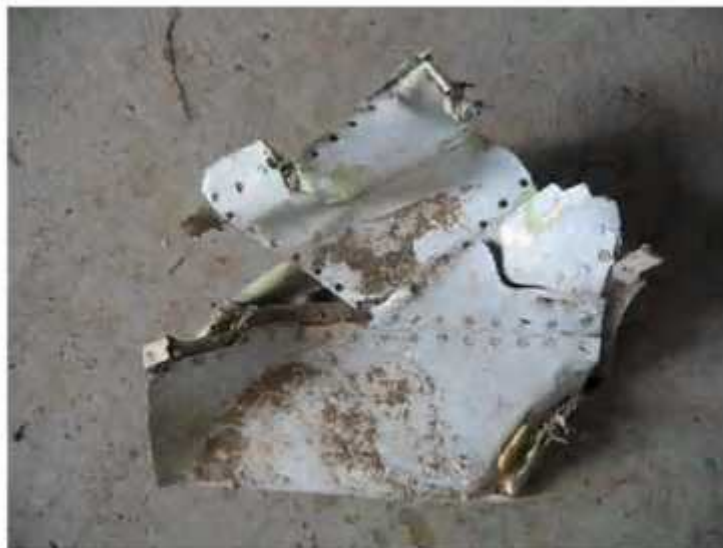
FIG 55 - 65-71926 Flipper Flap Assy – Inbd Trailing Edge Flap

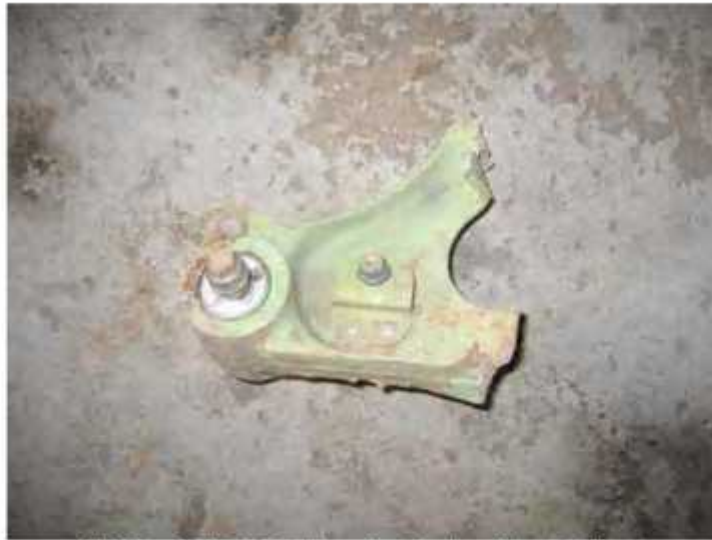
FIG 56 - 65-46995-15 Aileron Bus Quadrant Wing Sta 518,86

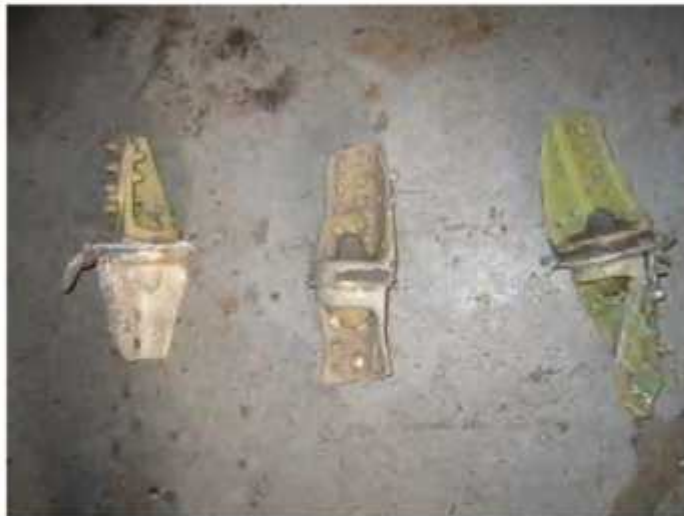
FIG 57 - 65-45437 series tension beam brackets on wing center section spanwise beam instal

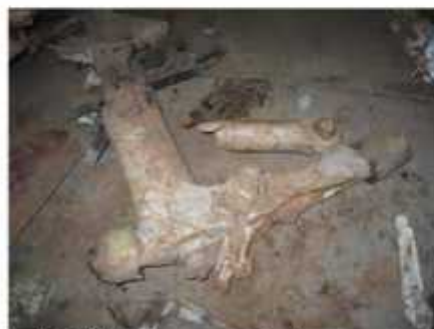
The entire left main landing gear was recovered. Local fire damage near the LH main gear. Tire fire. LH tires were burnt complete. Fire and/or smoke damage to the outboard end of the RH main landing gear support beam. No melted aluminum found.

FIG 59A LH upper main landing gear assy

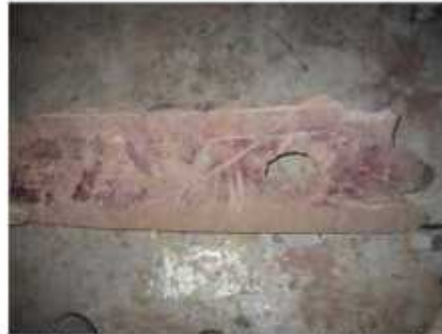
FIG 60 LH main landing gear support beam aft half – split on bond line.
Bearing bore shown.

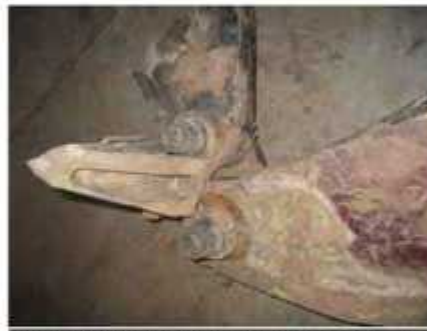
FIG 60A LH main landing gear support beam inbd end – split on bond line.
Shown attached to the swing link and body frame.

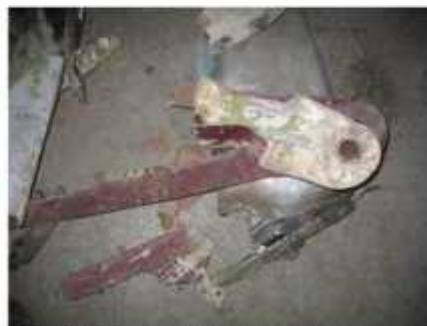
FIG 60B LH main landing gear support beam outbd end – split on bond line.
