*AIRCRAFT ACCIDENT REPORT*

*CIVIL AIRCRAFT ACCIDENT REPORT NO. CIA 129 ON  
AIRBUS A-310  
AT PORT-HARCOURT AIRPORT  
PORT-HARCOURT*

16th February, 1988.

This mishap involves Airbus A-310 model 221, serial numbered 329 with registration mark of 5N-AUG. It was operated by Nigeria Airways Limited as flight WT 104 and crashed in the landing phase on September 8th, 1987 at approximately 1756 hours UTC at Port-Harcourt International Airport, Rivers State.

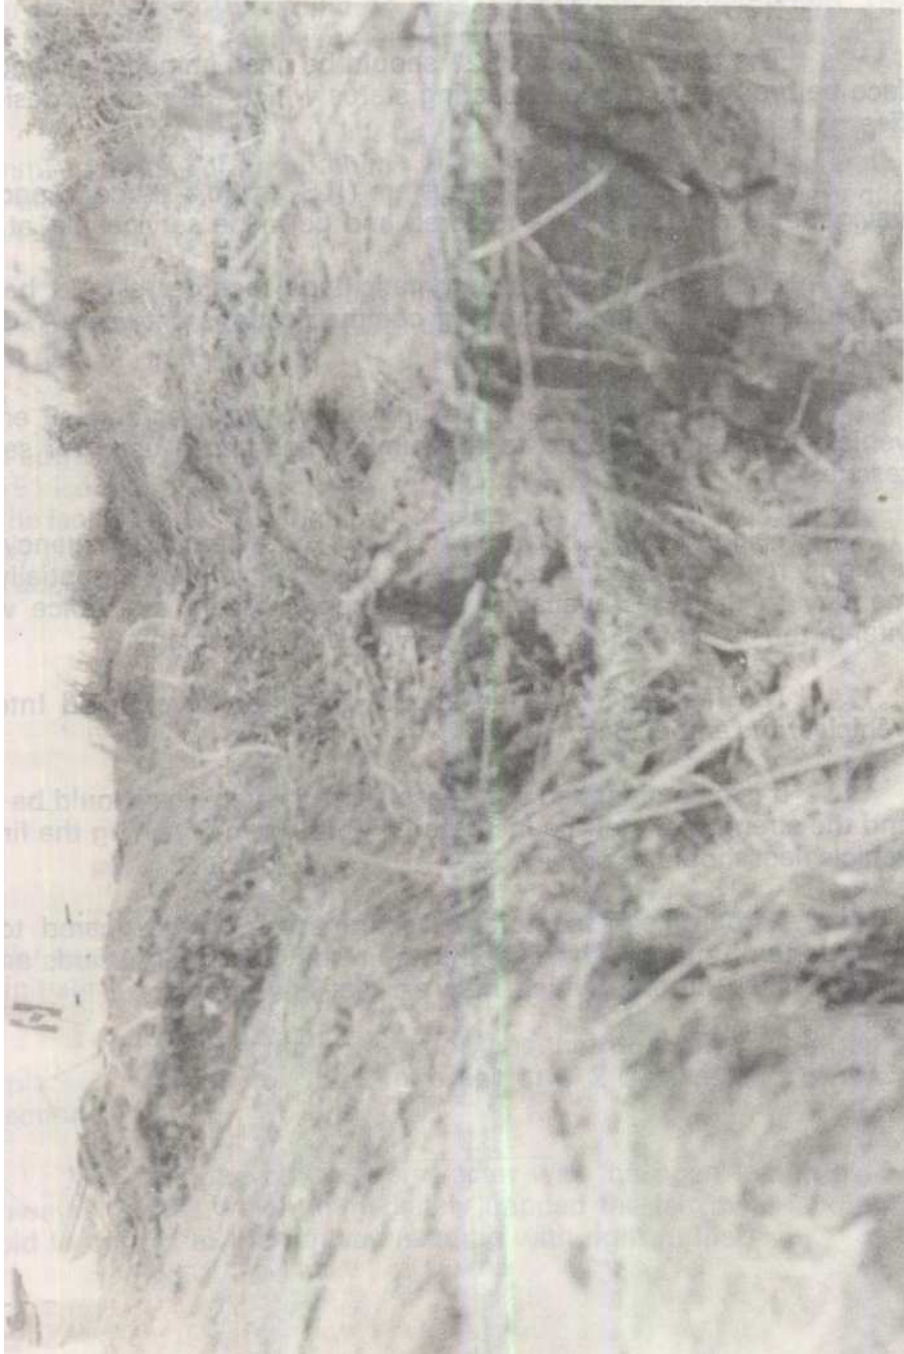
Plate No. 1

**1.10.4** There are open wide and deep trenches very close to the left side of runway 21 - These trenches are about one metre from the edge of the runway, on the immediate shoulder. They are about one metre deep and half a metre wide (see plate No. 1) from the beginning of runway 21 and continuing towards the beginning of runway 03

Port-Harcourt Airport was constructed to this specification; but the trench, for whatever purpose, has negated the purpose for which the shoulder was constructed. The trench inflicted the most devastating "structural damages" to the aircraft.

If the trench were meant for cable laying, it is surely, too wide, too deep and too close to the runway of that category. Besides, it should have been a quick disposable job, the soil of which should have been replaced and the shoulder's status brought back to its aircraft's weight-bearing specification.

- 3.1.11 The aircraft, therefore, ran off the runway onto the shoulder. The existence of a trench of such dimensions alongside the runway inflicted most damage to the aircraft.

**4.7** Aerodrome Inspectorate Department must be geared to inspect all airports on monthly basis and to point out potential hazards and advise against those hazards which may exist at any airport.
