AIRCRAFT ACCIDENT REPORT

DANAL/2019/01/23/F

**Final Report on the Serious Incident involving a Dornier
328-100 aircraft with nationality and registration marks
5N-DOX, operated by Dornier Aviation Nigeria AIEP
(DANA) Limited, which occurred at Port Harcourt Military
Airport On 23rd January, 2019**

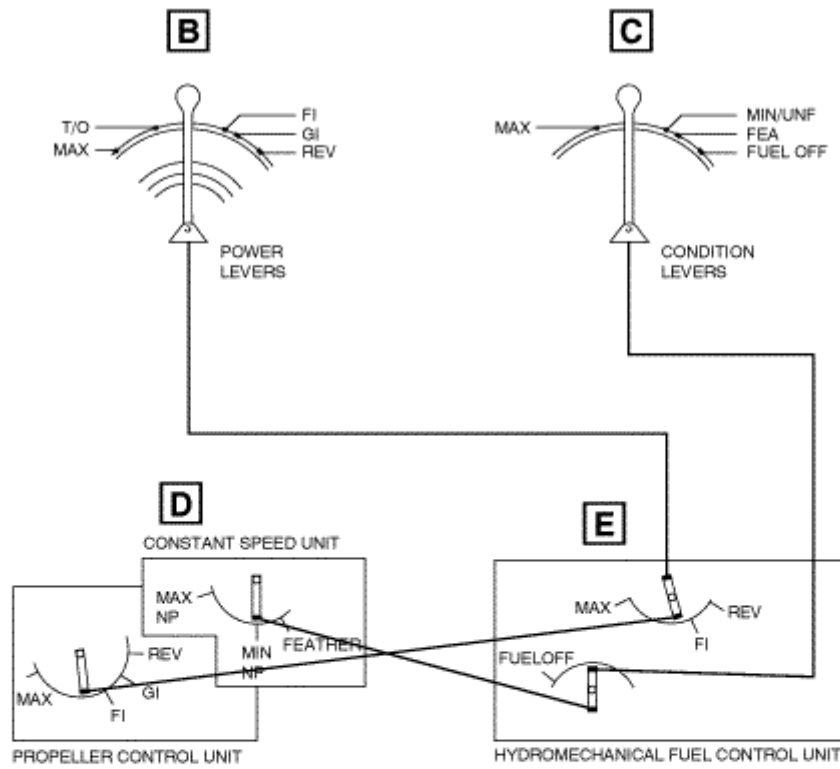
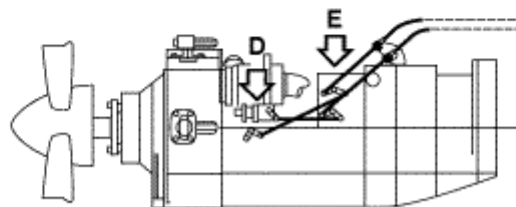
Propeller Control Component Location – Flight/Engine Compartment

The PCU houses the Beta valve, the Beta switch and the PCU servo piston which in turn operates the piston indicating rod and oil transfer tube. The PCU manifold provides a mounting for the feather solenoid valve.

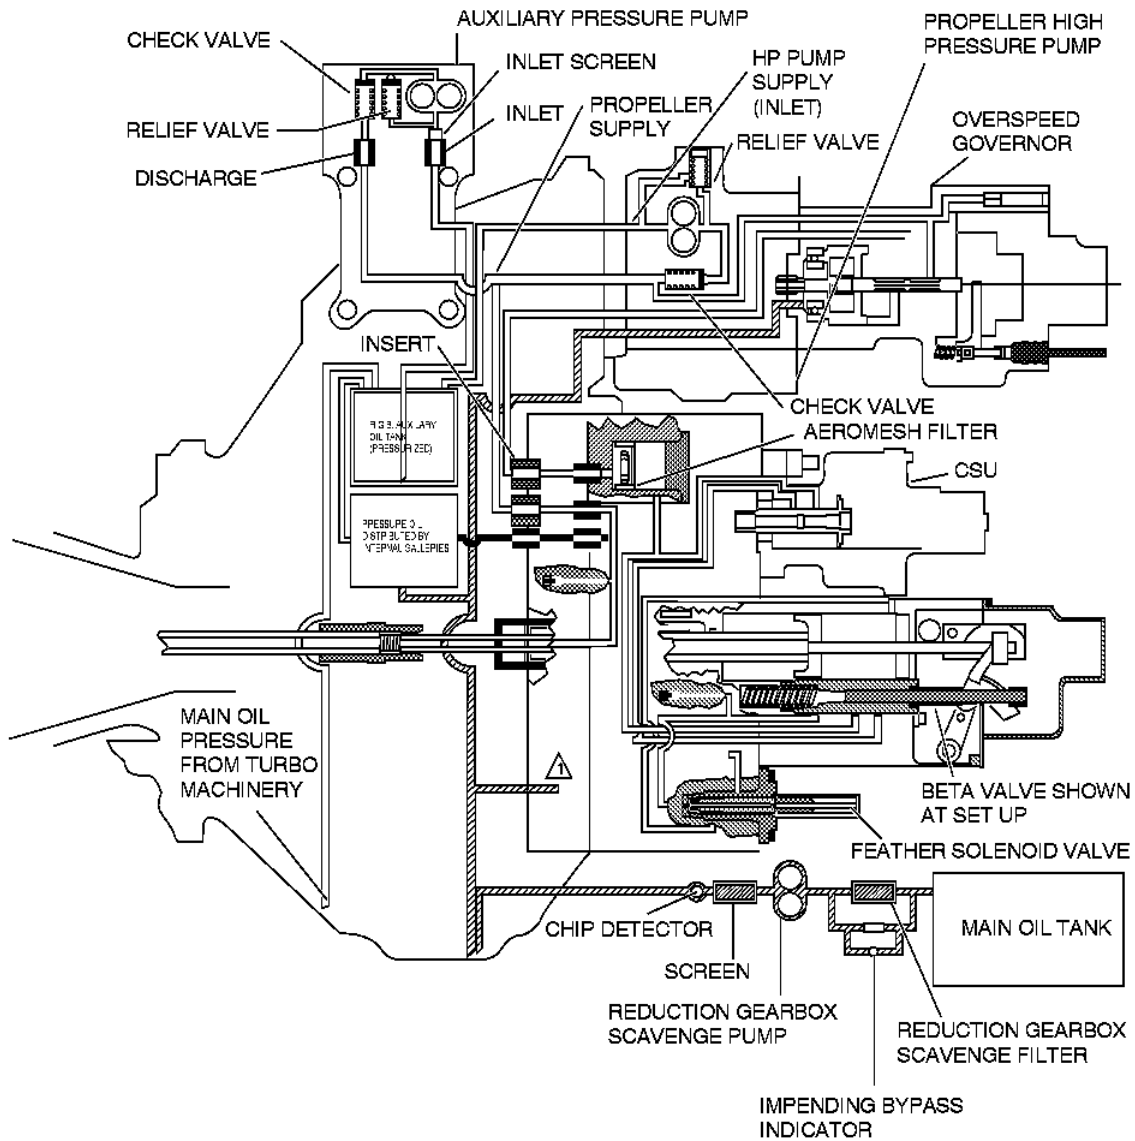
Propeller Control – System Schematic

The flight compartment CONDITION lever is connected by a control linkage to the constant speed unit (CSU) of the PCU. During flight the propeller control system operates in the governed mode, in which the propeller blade pitch is controlled automatically and the PCU maintains a constant propeller RPM determined by the position of the CONTROL lever.

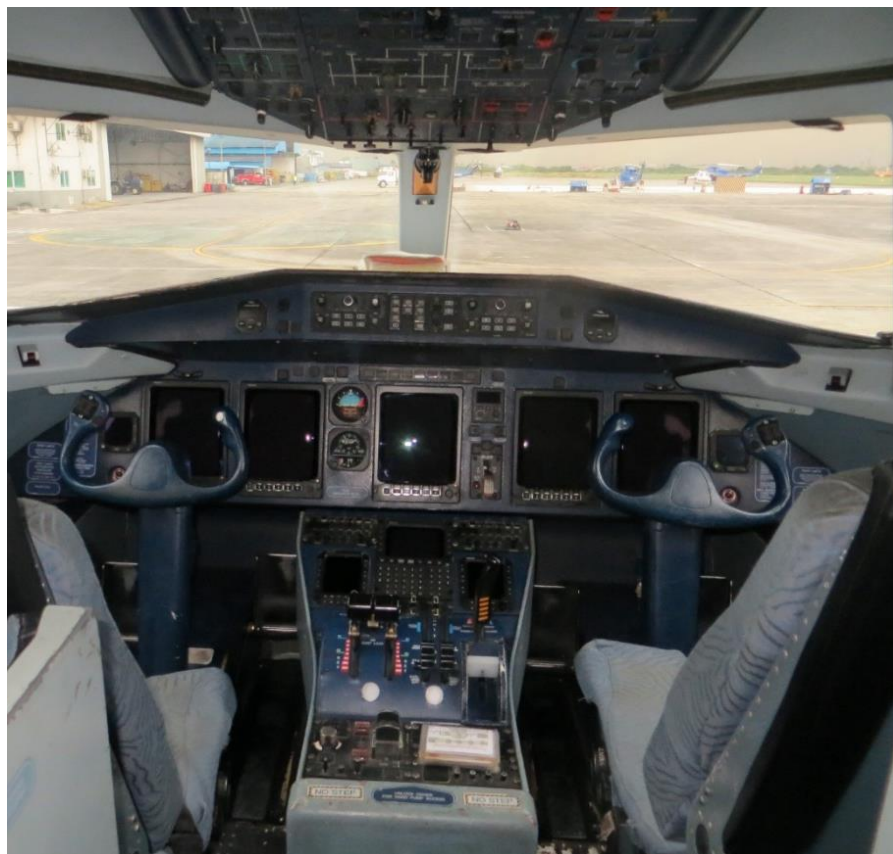
Figure 7: Flight deck of 5N-DOX

Each lever is connected to the HMU and controls the propeller RPM for aircraft take-off and the various flight configurations. The HMU and the constant speed unit of the propeller control unit are interconnected by a rod linkage.
