AIRCRAFT ACCIDENT REPORT

GAL/2020/09/10/F

Accident Investigation Bureau

**Final Report on the serious incident involving
BAe 125-800B aircraft with nationality and registration
marks 5N-B00 operated by Gyro Air Limited which
occurred at Osubi Airstrip, Warri, Nigeria On 10th
September, 2020**

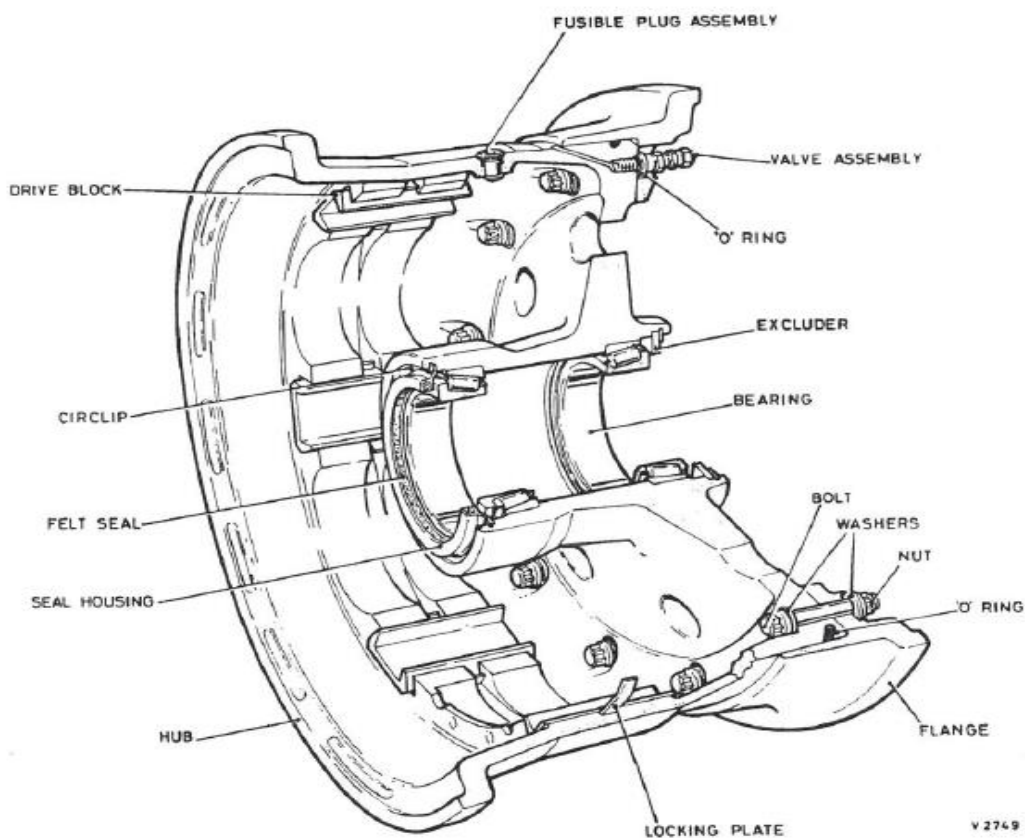
Figure 3: Section of the main wheel

This detachable flange type wheel, which is for use with a tubeless tyre, is designed to accommodate a plate brake and incorporate fusible plug assemblies which release[s] nitrogen from the tyre in the event of excessive heating.
