AIRCRAFT ACCIDENT REPORT

NCAT/2022/12/31/F

Nigerian Safety Investigation Bureau

Final Report on the Serious Incident involving Beech Baron 58 aircraft operated by Nigerian College of Aviation Technology (NCAT), Zaria with nationality and registration marks 5N-CAG which occurred on runway 05 at General Hassan Usman Katsina international Airport, Kaduna Nigeria on 31 December, 2022.

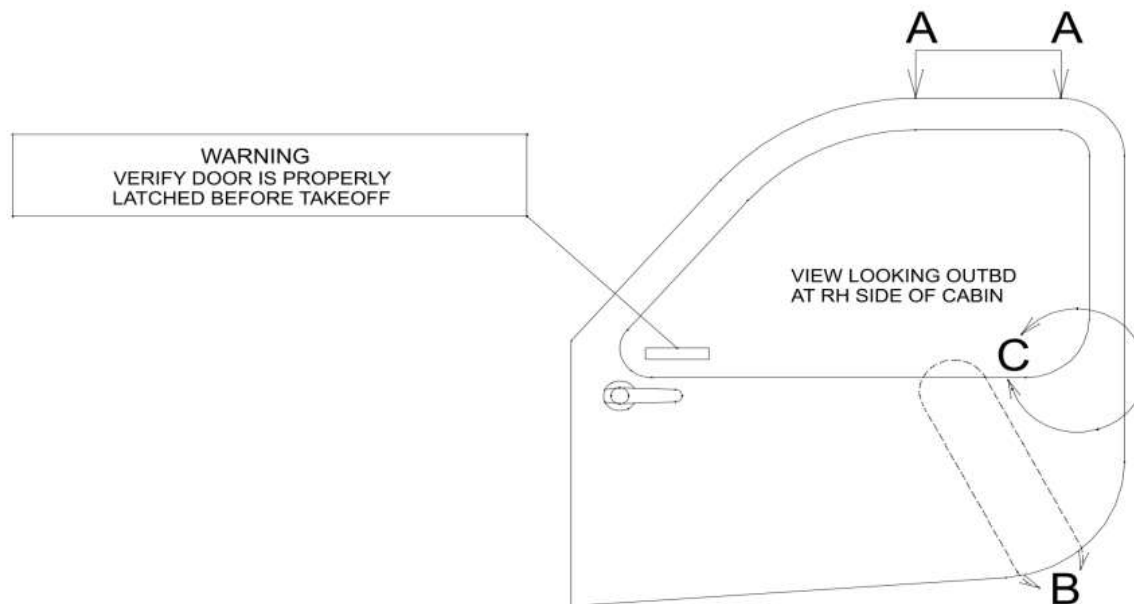
Figure 5: Cabin door latching point

During the site inspection, the Bureau observed that with the cockpit door closed and locked from the inside, indicating LOCKED, the door handles outside did not latch.
