Preliminary Report on accident involving a Boeing 737-400 aircraft with nationality and registration marks 5N-MBD operated by Max Air Limited, which occurred at Mallam Aminu Kano International Airport (DNKN), Kano Nigeria on 28 January 2025.

Operator:	Max Air Limited
Aircraft type and model:	Boeing 737-400
Manufacturer:	The Boeing Company, USA
Year of manufacture:	1997
Nationality and registration marks:	5N-MBD
Serial number:	28704
Location:	Runway 06, Mallam Aminu Kano International Airport (DNKN), Kano
Date and Time:	28 January 2025 at 22:49 h <i>(All times in this report are local time, equivalent to UTC+1 unless otherwise stated)</i>

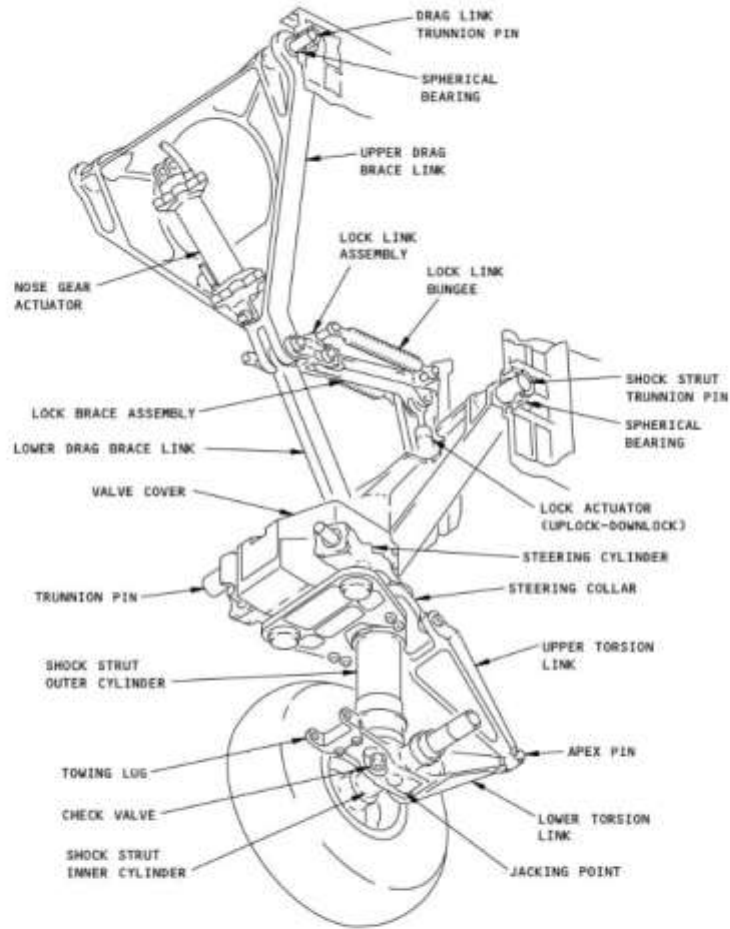
Nose Gear Component Location
Figure 1/32-21-00-990-801

A. The nose gear supports the forward end of the fuselage and provides directional control while the airplane is on the ground (Figure 1). The nose gear includes a drag brace, shock strut, and torsion links, and is hydraulically actuated to retract forward and up into a wheel well recessed into the lower nose section of the airplane. The shock strut consists of inner and outer cylinders. The upper part of the outer cylinder is "Y" shaped with arms extended to the sidewalls of the wheel well. Trunnion pins connect the gear to airplane structure. The "Y" arms and pins provide lateral stability. The gear rotates about the trunnion pins during extension and retraction. Refer to (PAGEBLOCK 32-33-00/001) for information on nose gear extension and retraction.

A. The nose gear steering collar is at the middle of the outer cylinder (Figure 1). The collar is held clamped around the outer cylinder, by a bolt, in an annular recess immediately below the trunnions. Both of the two steering cylinders are connected to the steering collar and the upper end of the upper torsion link is also connected to the steering collar. When force is applied to the steering collar, by either steering cylinder, the collar transfers the force through the torsion links to turn the inner cylinder to the right or left respectively to which cylinder force is applied to give steering action to the nose wheels.

A. The nose gear torsion links allow rotation between the inner and outer shock strut cylinders only when moved by the steering collar or when disconnected. The upper link is connected to the steering collar, and the lower link is connected to a lug on the inner cylinder (Figure 1). The upper and lower torsion links are joined together by an apex pin. This locks the nose wheels in the position assumed by the steering collar without affecting strut action. Steering forces applied to the steering collar by the nose gear steering system are transmitted to the inner cylinder by the torsion links.
