**Preliminary Report on the Accident involving a Boeing 737-400 Freighter aircraft with nationality and registration marks 5N-JRT operated by Allied Air Limited, which occurred at Nnamdi Azikiwe International Airport (DNAA) Abuja, Nigeria on 11 December 2024.**

<b>Operator:</b>	Allied Air Limited
<b>Aircraft type and model:</b>	Boeing 737-400F
<b>Manufacturer:</b>	The Boeing Company, USA
<b>Year of manufacture:</b>	1993
<b>Nationality and registration marks:</b>	5N-JRT
<b>Serial number:</b>	26081
<b>Location:</b>	Runway 22 Nnamdi Azikiwe International Airport (DNAA) Abuja
<b>Date and Time:</b>	11 December 2024 at 10:04 h (All times in this report are local time, equivalent to (UTC+1) unless otherwise stated)

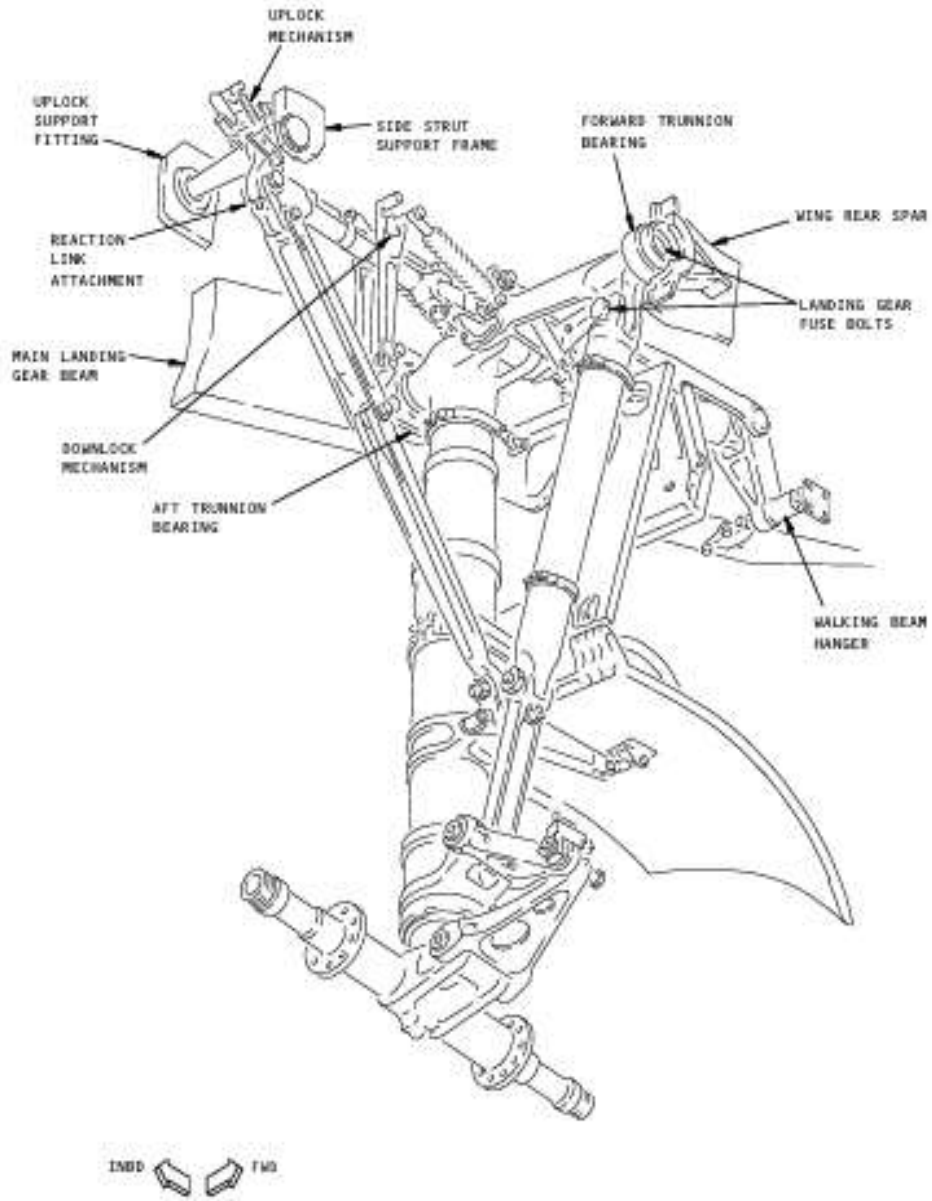
Main Gear Attachment  
Figure 2/32-11-00-990-802

**A.** *Each main gear consists of a trunnion link, a shock strut, a drag strut, torsion links, a damper, a side strut, and a reaction link. In addition, the right main gear carries ground-speed brake operating rods and cable.*

**B.** *The shock strut assembly is attached to the trunnion link by a pin joint, and the two are mounted between the rear wing spar and a trunnion support beam. The shock strut is charged with oil and compressed nitrogen to provide a shock-absorbing medium. The main gear axles and the shock strut inner cylinder are machined from a one-piece forging. Replaceable sleeves are assembled over the axles to provide a mounting for wheel bearings and to protect the axles from damage. The reaction link is connected to the shock strut and the upper end of the side strut.*
