# AIRCRAFT ACCIDENT REPORT

UNA/2021/11/17/F

**Nigerian Safety Investigation Bureau**

**Final Report on the Serious Incident involving Embraer 145LR aircraft operated by United Nigeria Airlines Limited with nationality and registration marks 5N-BWW, which occurred at about 4000 feet climbing out of Nnamdi Azikiwe International Airport, Abuja, Nigeria on 17 November 2021.**

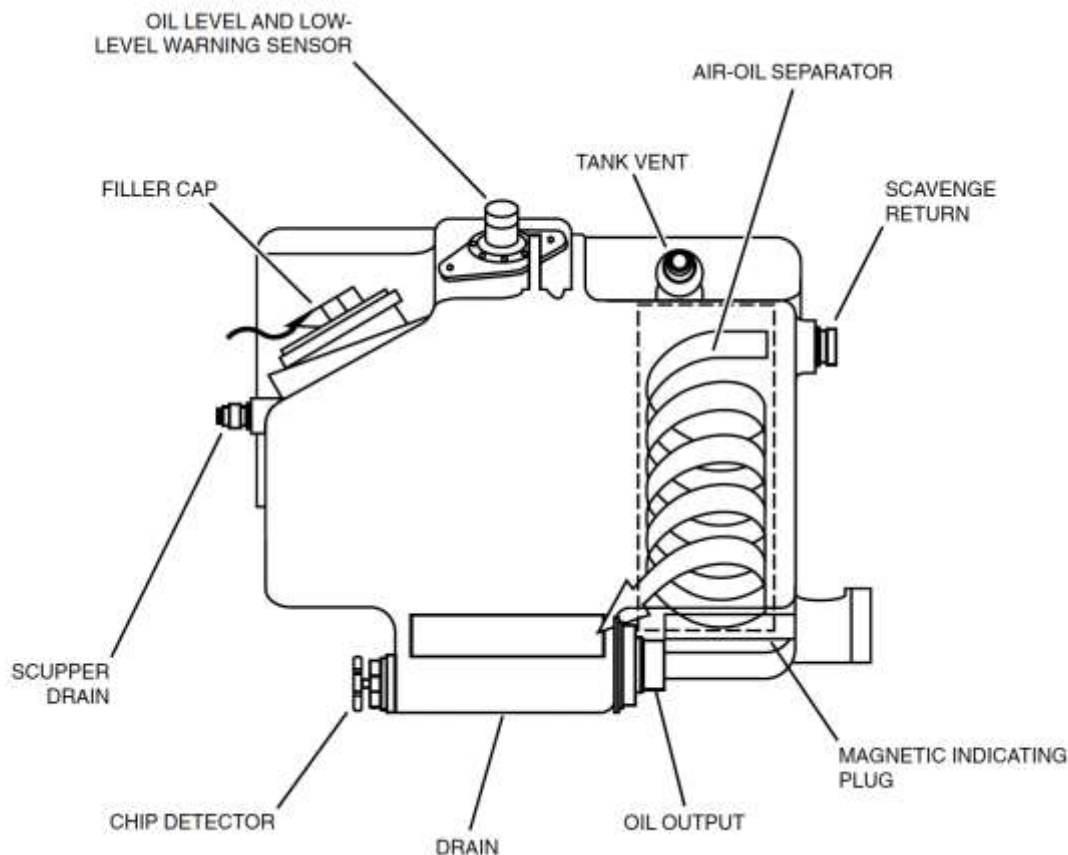
**Figure 4:** Oil Tank Indicating Components

The magnetic indicating plug (Figure 4) is located in the oil tank. The magnetic plug contacts are normally open and are electrically closed when conductive material bridges the gap between the contacts.

These indicators are located on the oil filter assembly (Figure 4) and activate when the pressure drop across the filter exceeds 22  $\frac{1}{2}$  psid. Both indicators have a thermal lockout when temperatures are below 55  $\frac{1}{2}$   $\frac{1}{2}$  F (13  $\frac{1}{2}$   $\frac{1}{2}$  C). When activated, the electrical indicator sends a signal to the EICAS.

The actual bypass indicator, shown in Figure 4, is a pop-up indicator which activates when the pressure drop across the filter is 30  $\frac{1}{2}$  psid. This information is not provided to the EICAS.

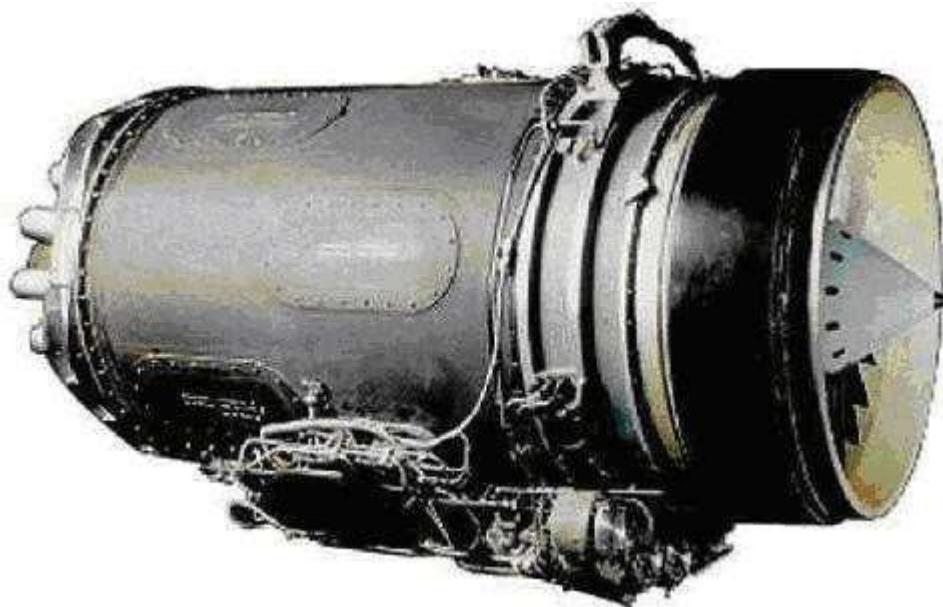
NOTE: This Condition Report serves as a Work Order Summary as required by US FAR 43-13 Appendix B, Para (b) for all FAR 145 Repair Stations. WORK SCOPE / REASON FOR REMOVAL: OIL SYSTEM CONTAMINATION
