MARINE ACCIDENT REPORT

Marine/2024/04/10/P/001

Nigerian Safety Investigation Bureau

Preliminary report on a Boat Accident that occurred at one nautical mile from Onono jetty in Anambra West LGA, Anambra State en route Asaba jetty in Asaba, Delta State on 10 April 2024 at about 12:30 h.

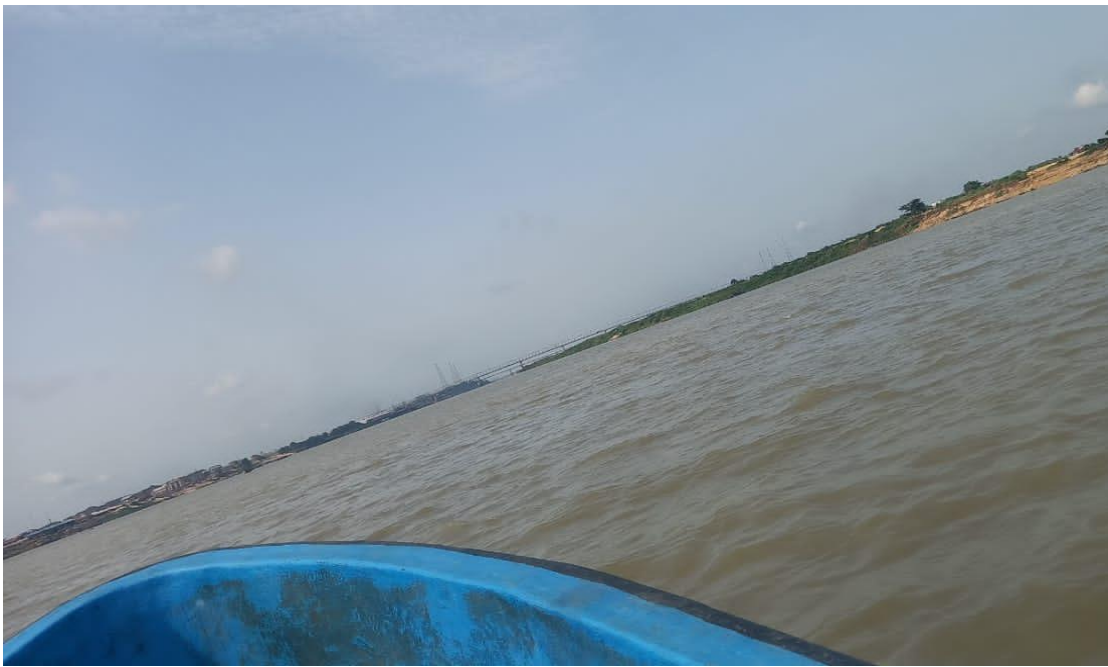
Figure 2: Approximate scene of the accident

At about 12:30 h, the Boat crashed into the crossing Canoe at high speed. This resulted in the Boat capsizing and all twelve passengers and the driver were flung into the Anam river.

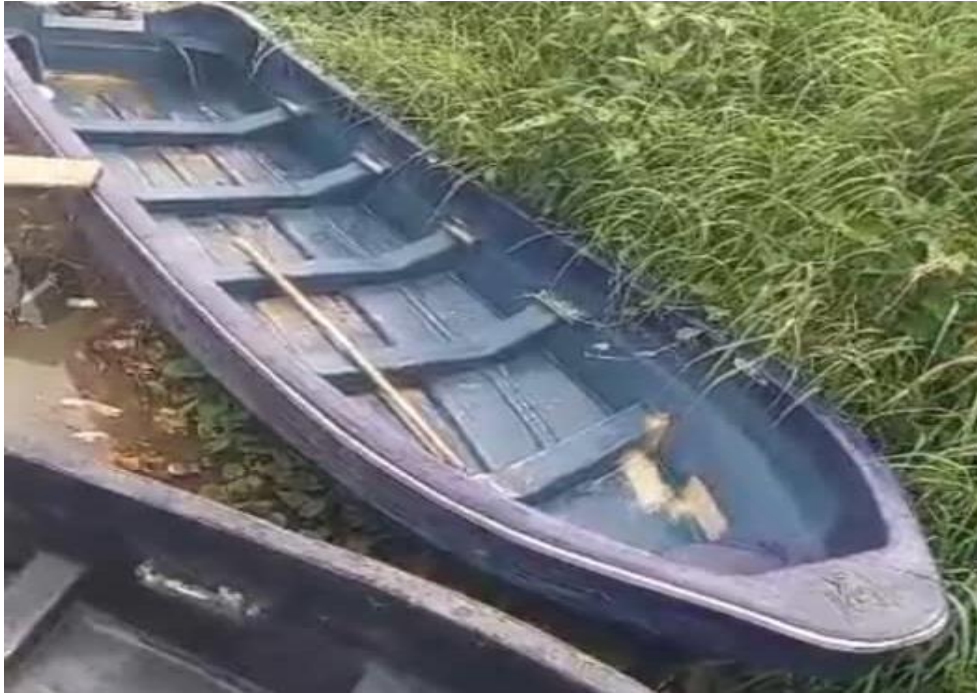
| Damage/environmental impact: | The boat sustained minor damage to the front deck and the fishing canoe sank into the Anam river |

The boat is constructed from synthetic fibre and is fitted with a Yamaha outboard engine to propel it. The boat was not registered with the National Inland Waterways Authority (NIWA), the regulator of inland waterway transport in Nigeria.

Figure 4: The outboard engine fibre boat

Ensure that all boats involved in commercial activities (goods and passengers) within the national inland waterways are registered.

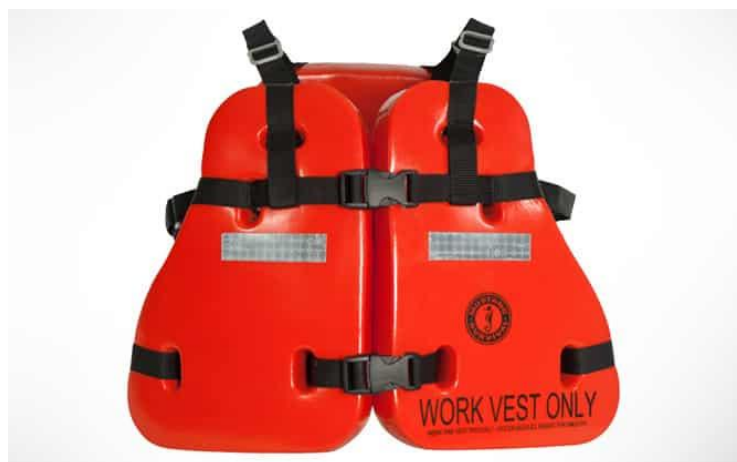
Figure 5: Personal flotation device (Life jacket)

The purpose of a life jacket is to keep the user afloat in water, allow the wearer to be seen and to alert rescuers or witnesses that a person is in water, especially in low visibility situations, greatly increasing their likelihood of survival.
